# Rooted Tree Services

## ARBORIST REPORT ADDENDUM

**DATE:** 24 February 2026

**LOCATION:** Basement Flooding Protection Project, Assignment 36-01, 36-03, 36-06, 36-09, 36-11, 36-17

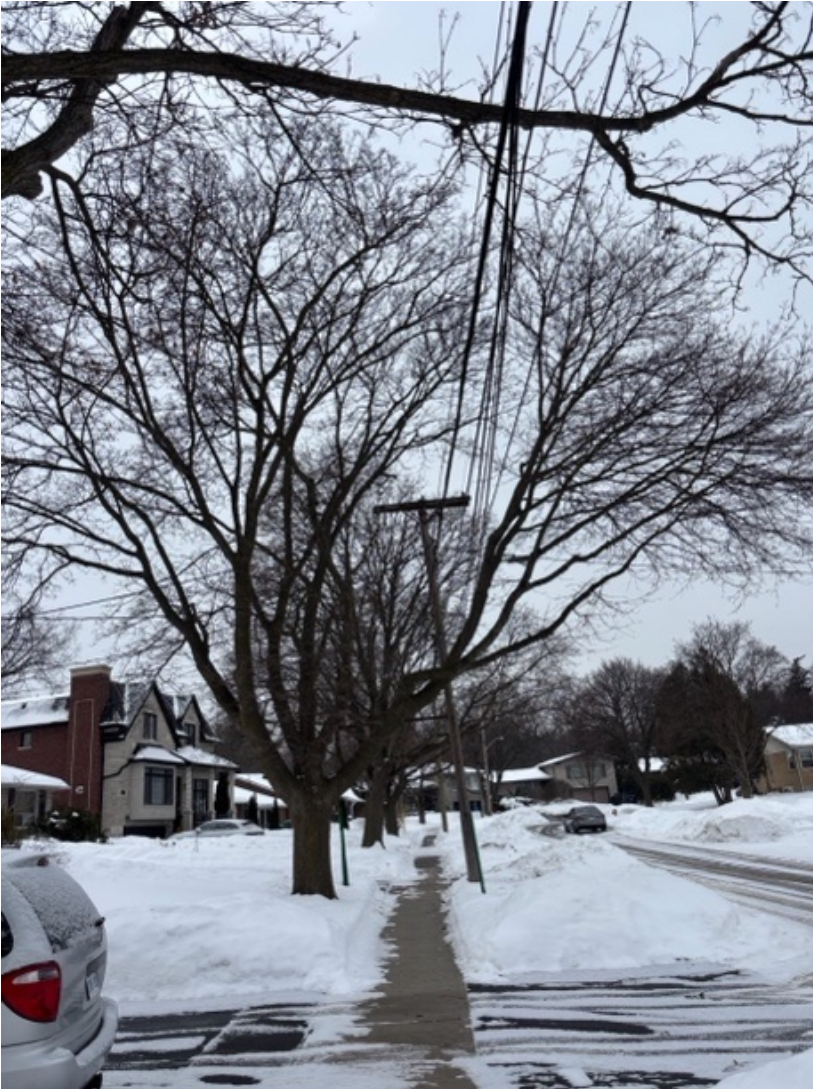
Photo 1. Tree 249

| Nearest Address | Tree # | Scientific Name | Common Name | DBH (cm) | Category | TPZ Encroachment | Construction Comments | Crown Pruning Required | Crown Pruning Comments | Status Prune - no injury, Injury (permit), Remove (permit), Removal recommended (condition) | Required Compensation |
|---|---|---|---|---|---|---|---|---|---|---|---|
| 5 Saxony Crescent | 249 | <i>Acer platanoides</i> | Norway Maple | 70 | 5 | No | | <5% | 1x8cm branch to accommodate equipment | Prune - no injury | |

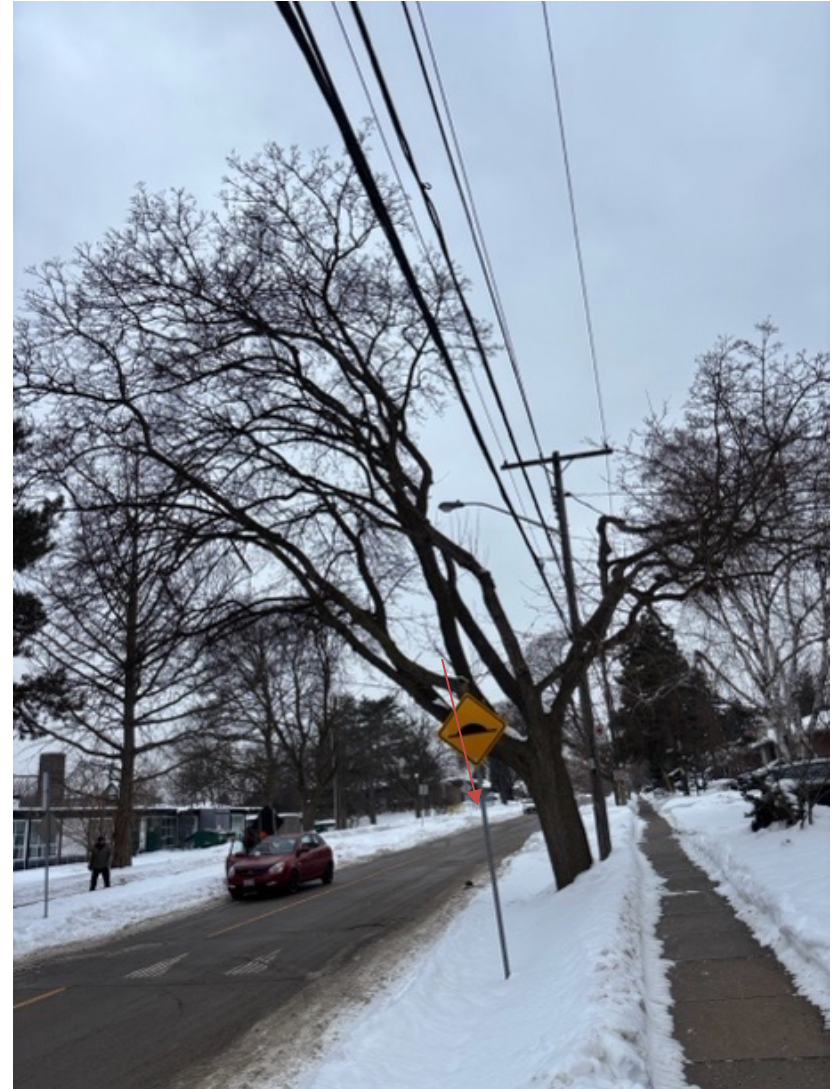
Photo 2. Tree 470

| Nearest Address | Tree # | Scientific Name | Common Name | DBH (cm) | Category | TPZ Encroachment | Construction Comments | Crown Pruning Required | Crown Pruning Comments | Status Prune - no injury, Injury (permit), Remove (permit), Removal recommended (condition) | Required Compensation |
|---|---|---|---|---|---|---|---|---|---|---|---|
| 70 Chapman Road | 470 | <i>Acer platanoides</i> | Norway Maple | 66 | 5 | No | | 35% | 2x20cm branches and 2x10cm branches to accommodate equipment (tree in poor condition) | Injury (permit) | |

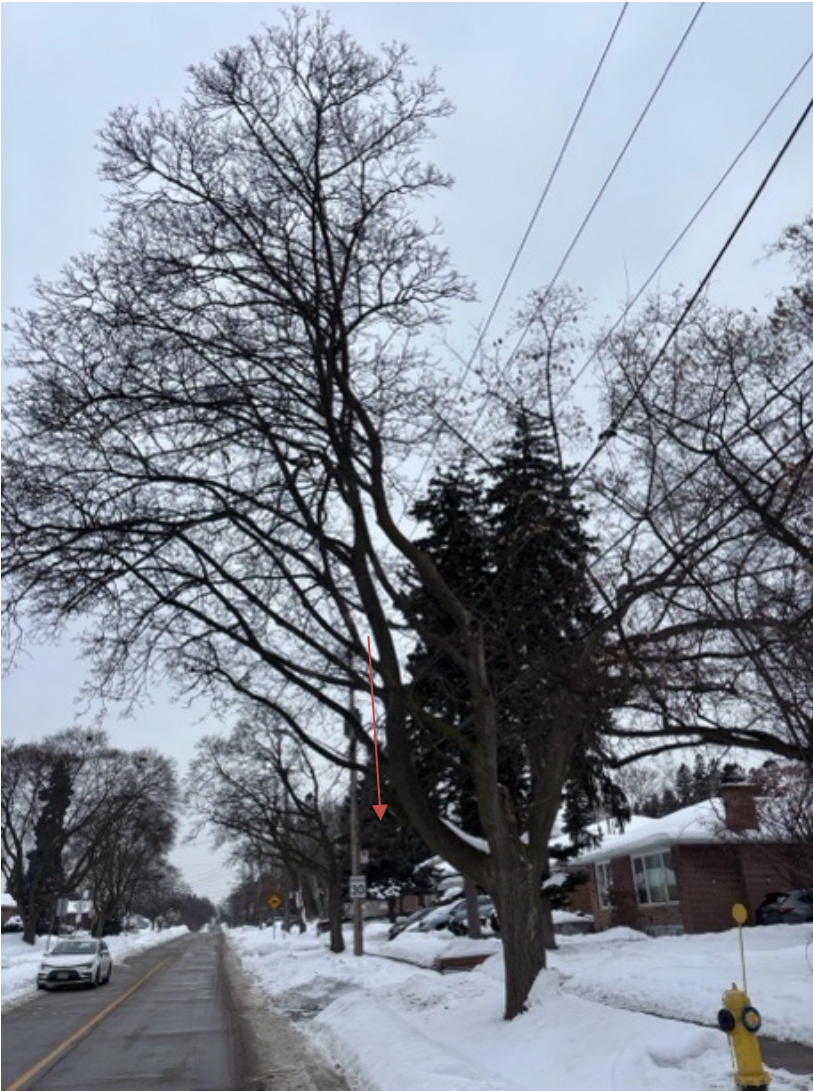
**Photo 3. Tree 459**

| Nearest Address | Tree # | Scientific Name | Common Name | DBH (cm) | Category | TPZ Encroachment | Construction Comments | Crown Pruning Required | Crown Pruning Comments | Status Prune - no injury, Injury (permit), Remove (permit), Removal recommended (condition) | Required Compensation |
|---|---|---|---|---|---|---|---|---|---|---|---|
| 76 Chapman Road | 459 | <i>Acer platanoides</i> | Norway Maple | 62 | 5 | No | | 30% | 1x15cm branch, 1x10cm branch and 3x8cm branches to accommodate equipment | Injury (permit) | |

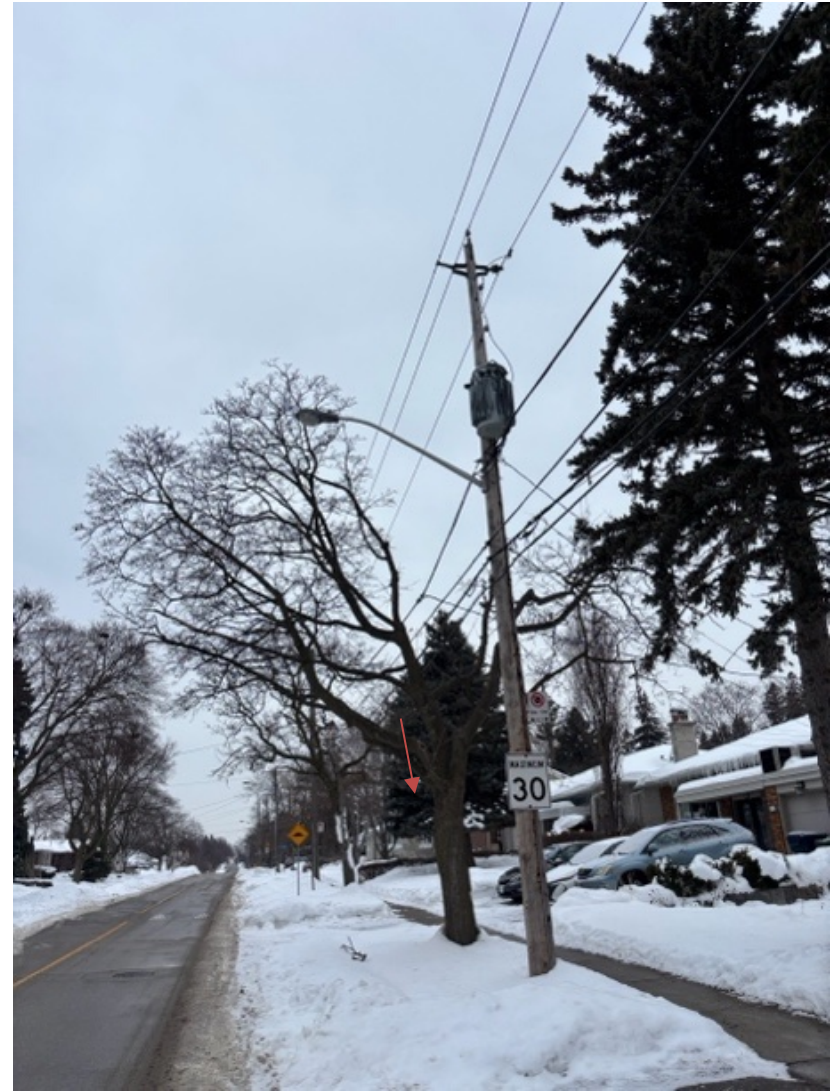
**Photo 4. Tree 454**

| Nearest Address | Tree # | Scientific Name | Common Name | DBH (cm) | Category | TPZ Encroachment | Construction Comments | Crown Pruning Required | Crown Pruning Comments | Status Prune - no injury, Injury (permit), Remove (permit), Removal recommended (condition) | Required Compensation |
|---|---|---|---|---|---|---|---|---|---|---|---|
| 78 Chapman Road | 454 | <i>Acer platanoides</i> | Norway Maple | 42 | 5 | No | | 20% | 2x8cm branches to accommodate equipment (tree in poor condition) | Injury (permit) | |

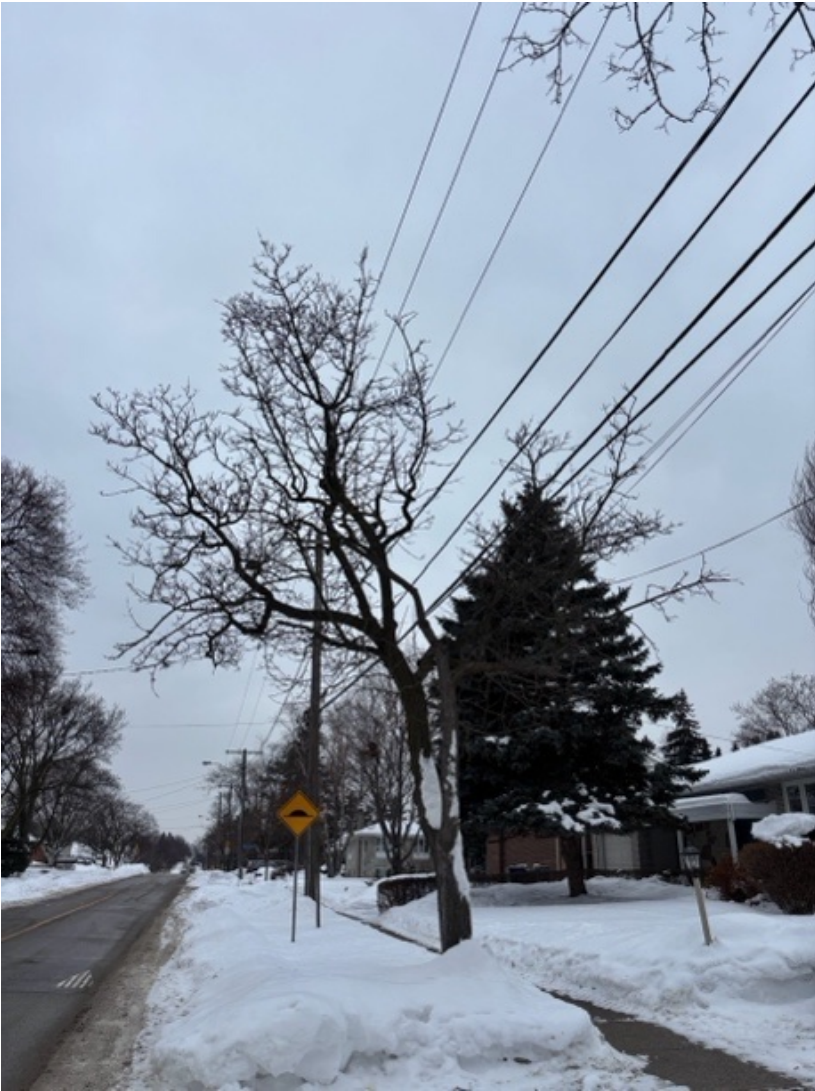
**Photo 5. Tree 452**

| Nearest Address | Tree # | Scientific Name | Common Name | DBH (cm) | Category | TPZ Encroachment | Construction Comments | Crown Pruning Required | Crown Pruning Comments | Status Prune - no injury, Injury (permit), Remove (permit), Removal recommended (condition) | Required Compensation |
|---|---|---|---|---|---|---|---|---|---|---|---|
| 80 Chapman Road | 452 | <i>Acer platanoides</i> | Norway Maple | 34 | 5 | No | | 10% | 5x6cm branches to accommodate equipment | Prune - no injury | |

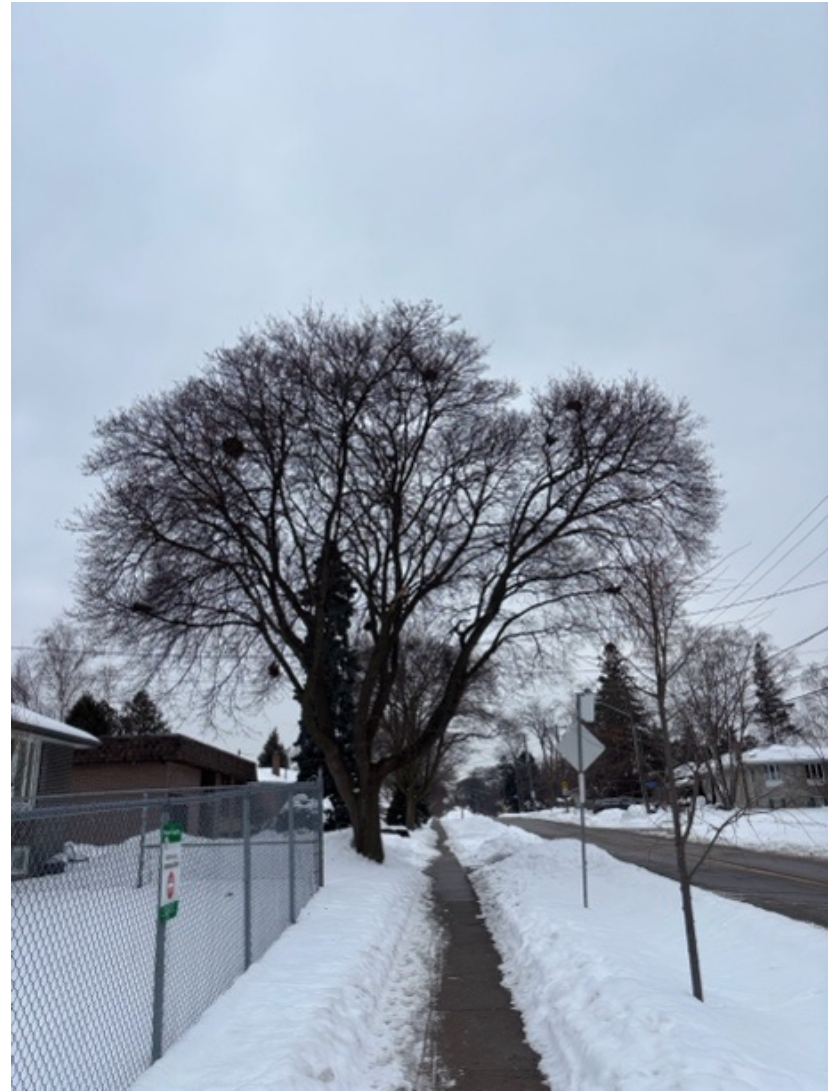
**Photo 6. Trees 605 and 606**

| Nearest Address | Tree # | Scientific Name | Common Name | DBH (cm) | Category | TPZ Encroachment | Construction Comments | Crown Pruning Required | Crown Pruning Comments | Status Prune - no injury, Injury (permit), Remove (permit), Removal recommended (condition) | Required Compensation |
|---|---|---|---|---|---|---|---|---|---|---|---|
| 80 Chapman Road | 605 | <i>Tilia cordata</i> | Little-leaf Linden | 2 | 5 | | Proposed catchbasin and sanitary sewer | | | Removal (permit) | 3 |
| 105 Chapman Road | 606 | <i>Acer platanoides</i> | Norway Maple | 70 | 1/5 | Yes | Proposed sanitary sewer | 15% | 1x15cm branch and 3x6cm branches to accommodate equipment | Injury (permit) | |

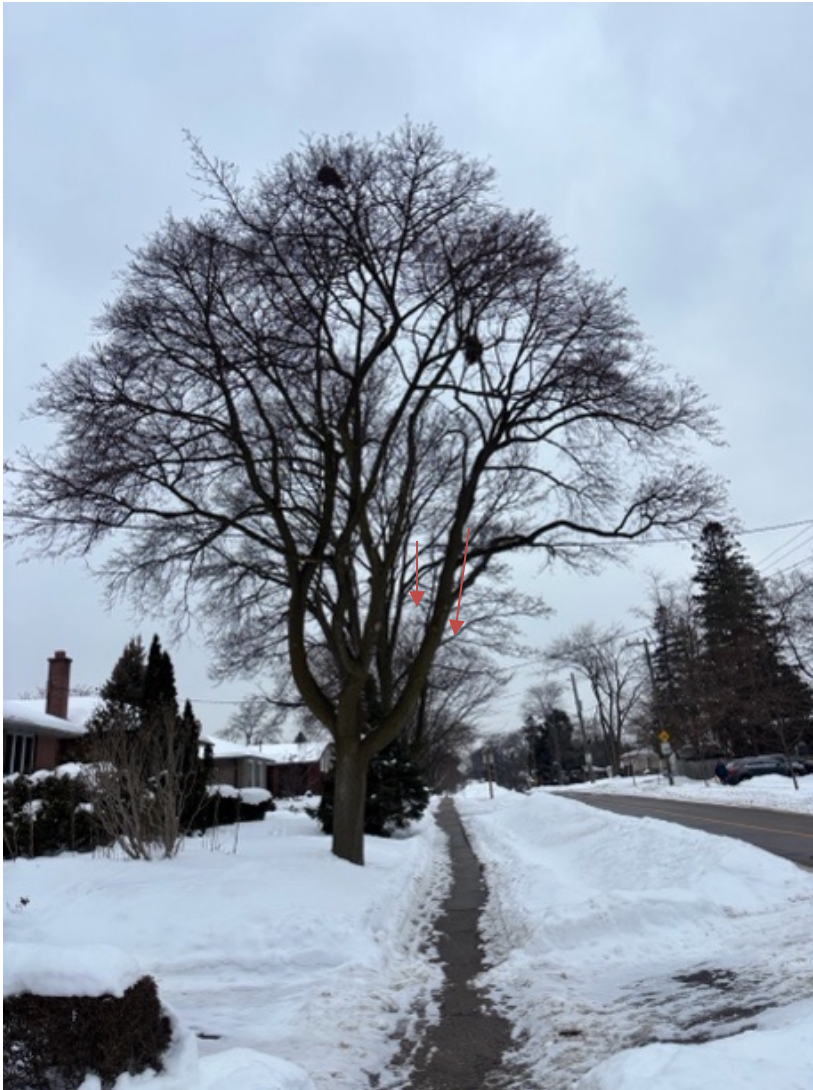
**Photo 7. Tree 608**

| Nearest Address | Tree # | Scientific Name | Common Name | DBH (cm) | Category | TPZ Encroachment | Construction Comments | Crown Pruning Required | Crown Pruning Comments | Status Prune - no injury, Injury (permit), Remove (permit), Removal recommended (condition) | Required Compensation |
|---|---|---|---|---|---|---|---|---|---|---|---|
| 109 Chapman Road | 608 | <i>Acer platanoides</i> | Norway Maple | 53 | 1/5 | Yes | Proposed catchbasin and drop structure | 30% | 3x10cm branches and 2x5cm branches to accommodate equipment | Injury (permit) | |

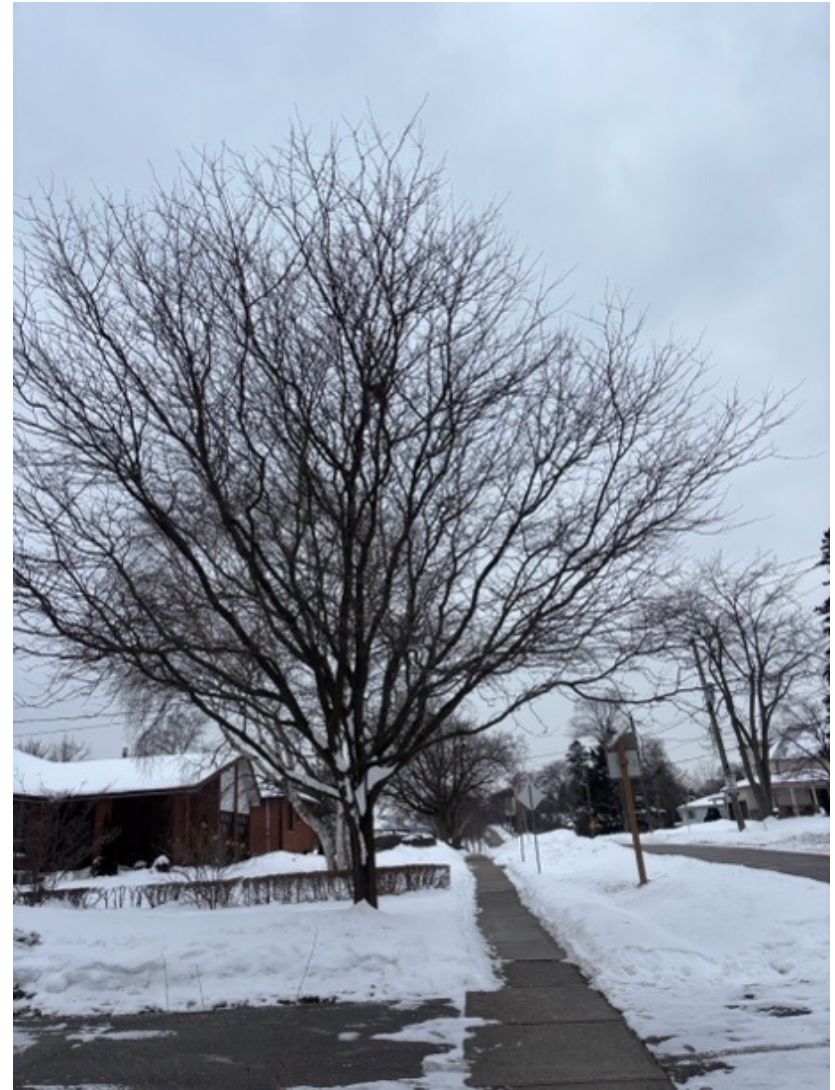
**Photo 8. Tree 612**

| Nearest Address | Tree # | Scientific Name | Common Name | DBH (cm) | Category | TPZ Encroachment | Construction Comments | Crown Pruning Required | Crown Pruning Comments | Status Prune - no injury, Injury (permit), Remove (permit), Removal recommended (condition) | Required Compensation |
|---|---|---|---|---|---|---|---|---|---|---|---|
| 113 Chapman Road | 612 | <i>Gleditsia triacanthos inermis</i> | Thornless Honey Locust | 26 | 1/5 | Yes | Proposed catchbasin | <5% | 2x2cm branches to accommodate equipment | Injury (permit) | |

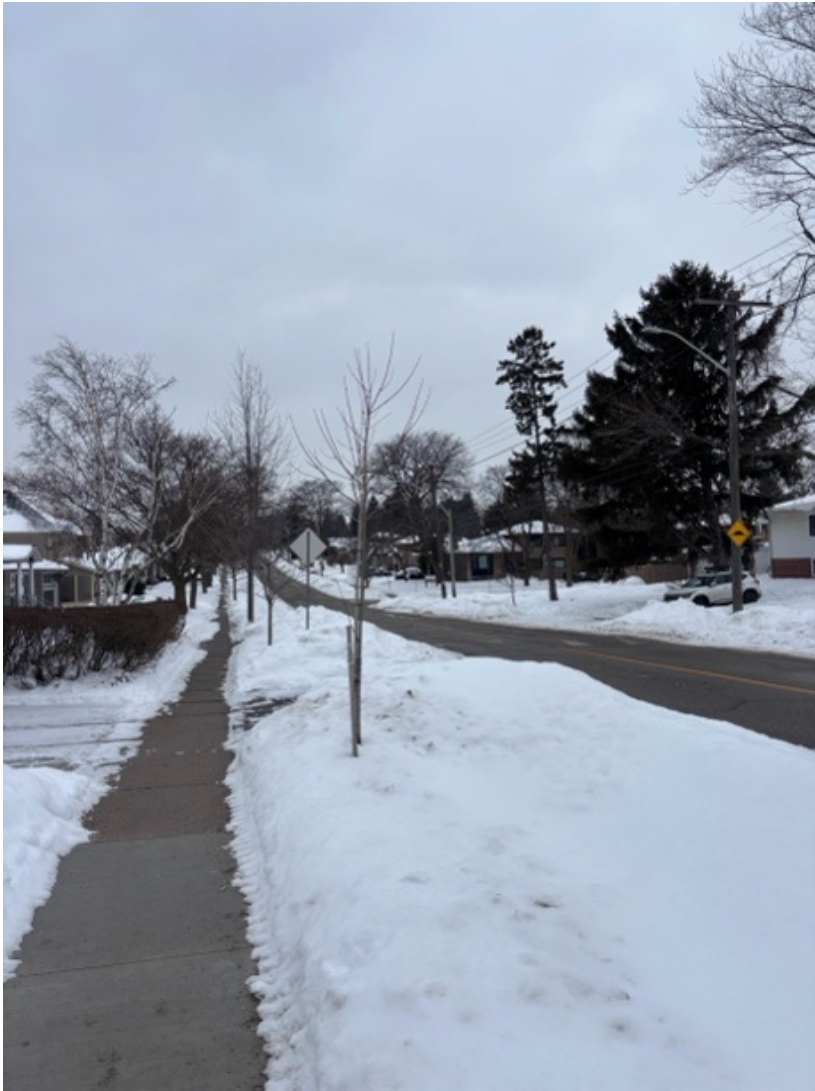
**Photo 9. Tree 865**

| Nearest Address | Tree # | Scientific Name | Common Name | DBH (cm) | Category | TPZ Encroachment | Construction Comments | Crown Pruning Required | Crown Pruning Comments | Status Prune - no injury, Injury (permit), Remove (permit), Removal recommended (condition) | Required Compensation |
|---|---|---|---|---|---|---|---|---|---|---|---|
| 121 Chapman Road | 865 | <i>Acer x freemanii</i> | Freeman Maple | 3 | 5 | | Proposed catchbasin and sanitary sewer | | | Removal (permit) | 3 |

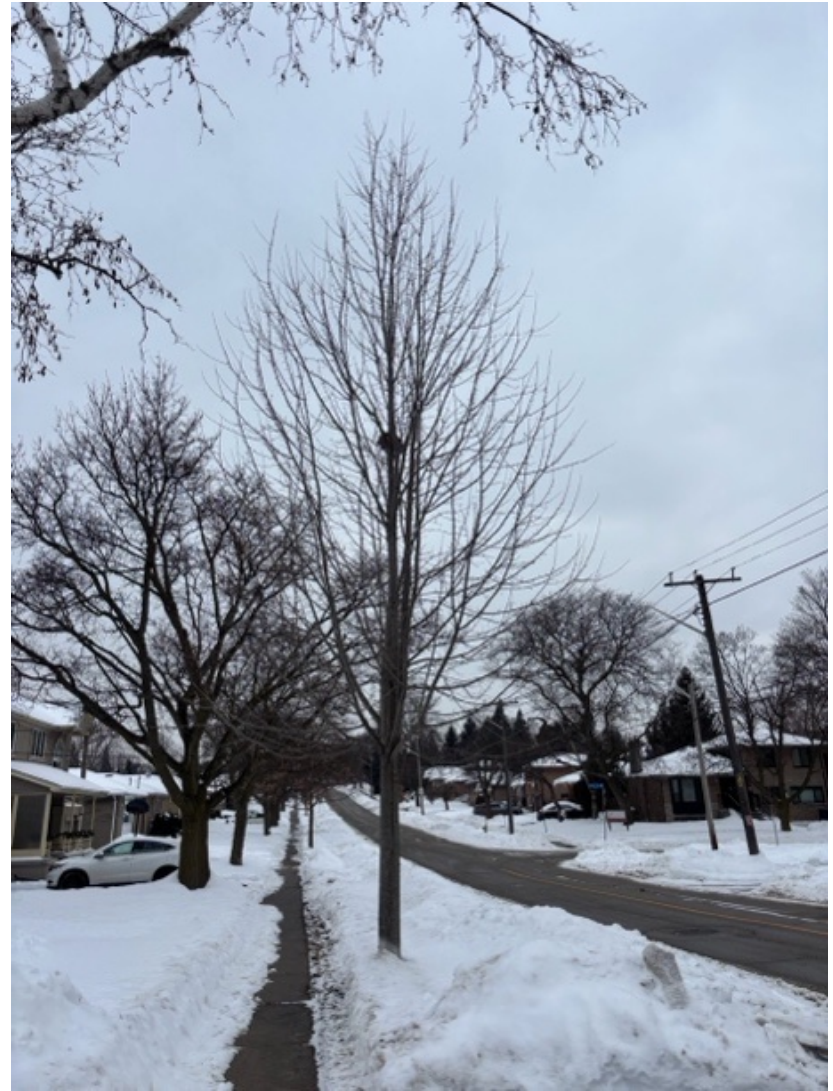
**Photo 10. Tree 862**

| Nearest Address | Tree # | Scientific Name | Common Name | DBH (cm) | Category | TPZ Encroachment | Construction Comments | Crown Pruning Required | Crown Pruning Comments | Status Prune - no injury, Injury (permit), Remove (permit), Removal recommended (condition) | Required Compensation |
|---|---|---|---|---|---|---|---|---|---|---|---|
| 123 Chapman Road | 862 | <i>Acer x freemanii</i> | Freeman Maple | 12 | 5 | | Proposed sanitary sewer | | | Removal (permit) | 3 |

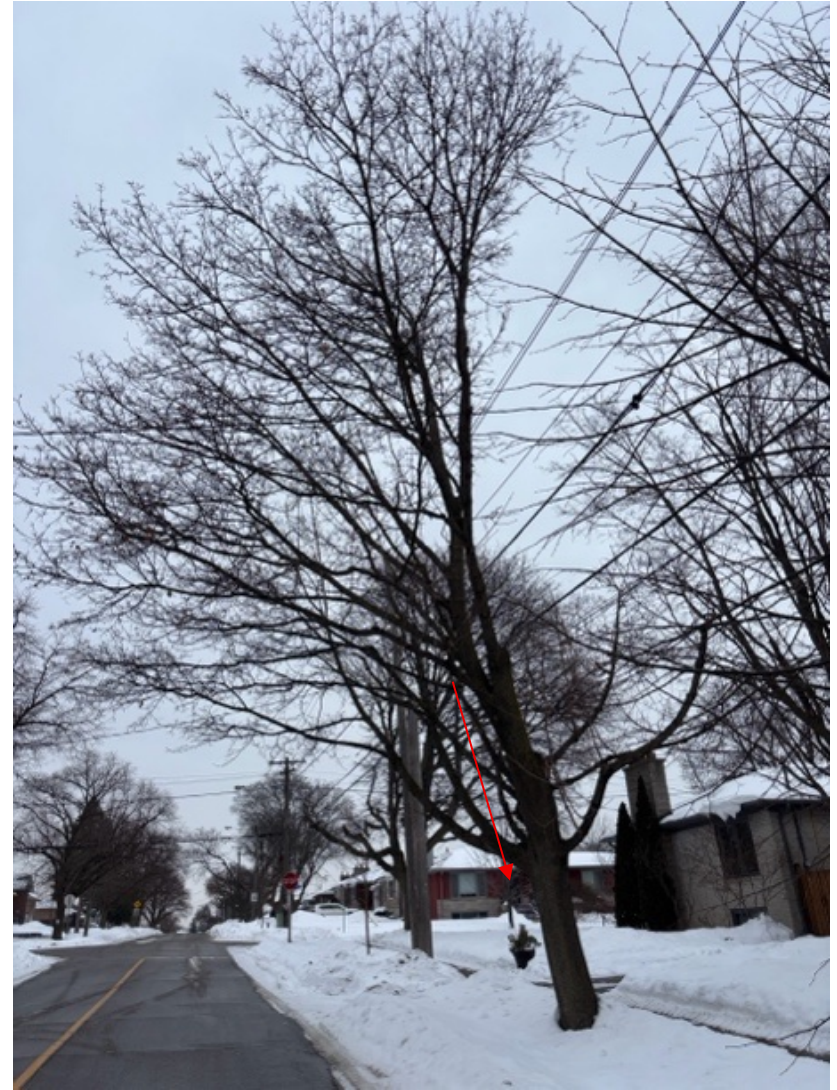
**Photo 14. Tree 829**

| Nearest Address | Tree # | Scientific Name | Common Name | DBH (cm) | Category | TPZ Encroachment | Construction Comments | Crown Pruning Required | Crown Pruning Comments | Status Prune - no injury, Injury (permit), Remove (permit), Removal recommended (condition) | Required Compensation |
|---|---|---|---|---|---|---|---|---|---|---|---|
| 140 Chapman Road | 829 | <i>Acer platanoides</i> | Norway Maple | 44 | 5 | No | | 50% | 2x10cm branches and 3x5cm branches to accommodate equipment | Injury (permit) | |

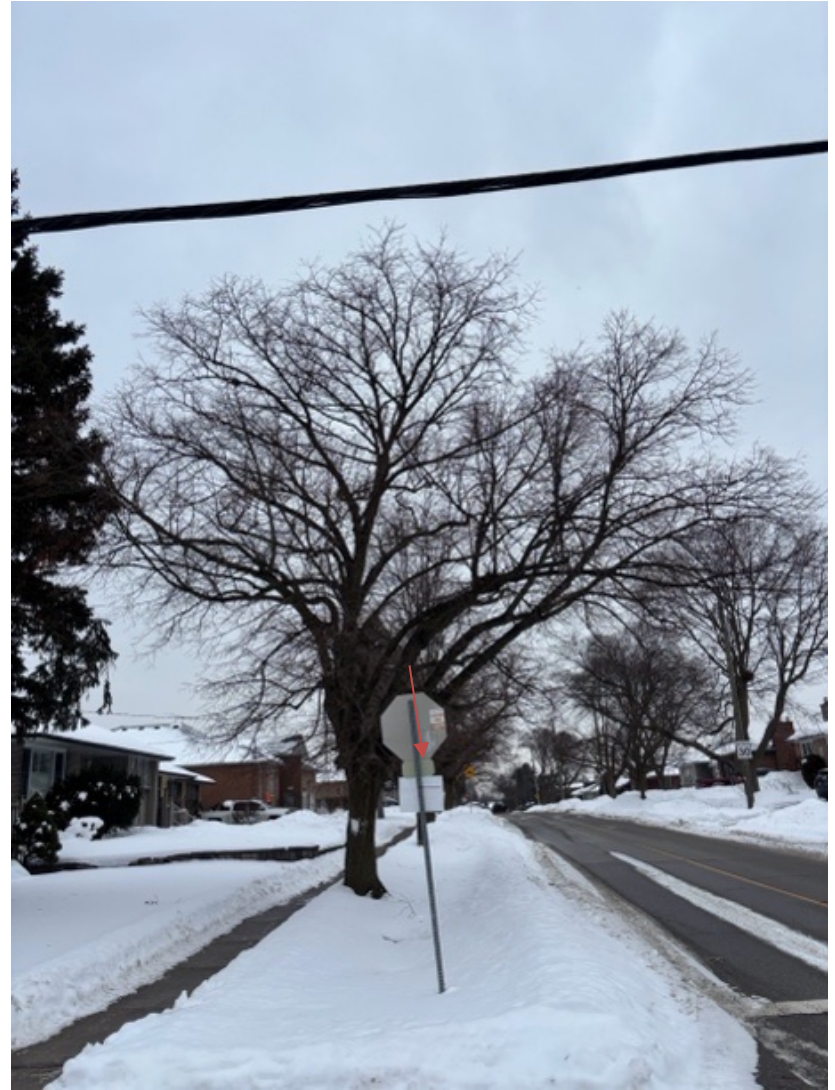
**Photo 16. Tree 767**

| Nearest Address | Tree # | Scientific Name | Common Name | DBH (cm) | Category | TPZ Encroachment | Construction Comments | Crown Pruning Required | Crown Pruning Comments | Status Prune - no injury, Injury (permit), Remove (permit), Removal recommended (condition) | Required Compensation |
|---|---|---|---|---|---|---|---|---|---|---|---|
| 169 Chapman Road | 767 | <i>Tilia cordata</i> | Little-leaf Linden | 52 | 5 | No | | 25% | 2x10cm branches and 4x5cm branches to accommodate equipment | Injury (permit) | |

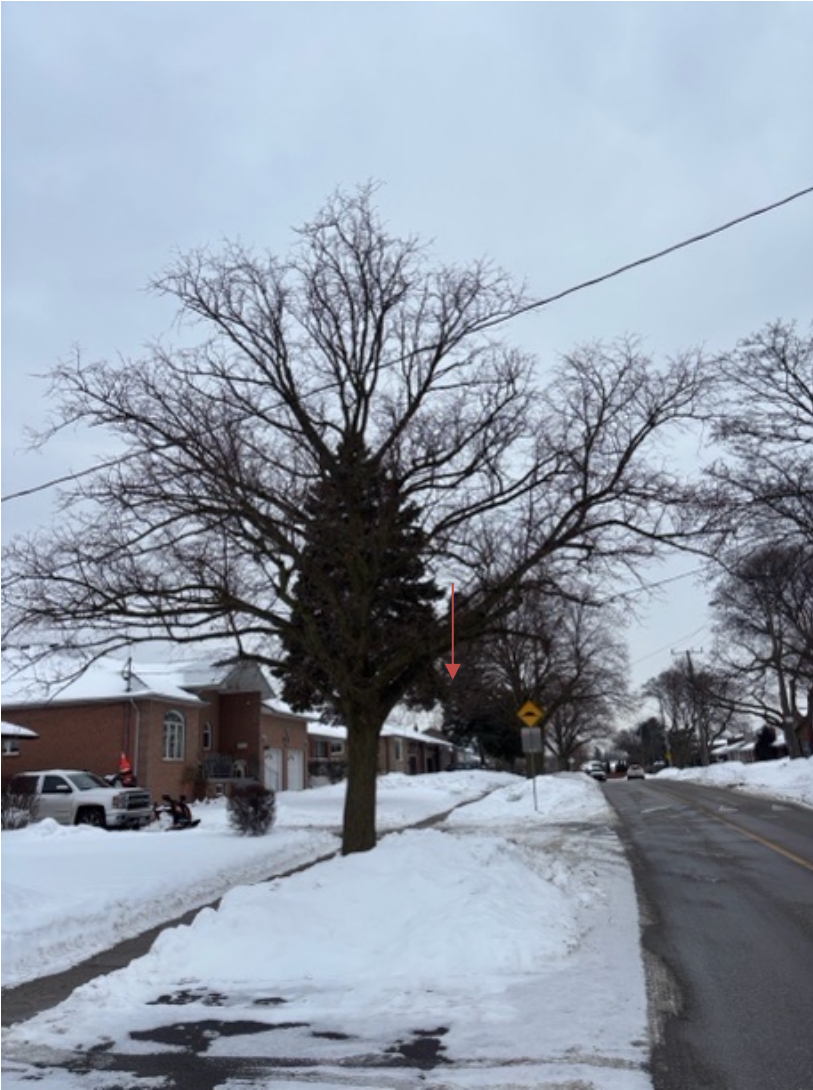
**Photo 17. Tree 769**

| Nearest Address | Tree # | Scientific Name | Common Name | DBH (cm) | Category | TPZ Encroachment | Construction Comments | Crown Pruning Required | Crown Pruning Comments | Status Prune - no injury, Injury (permit), Remove (permit), Removal recommended (condition) | Required Compensation |
|---|---|---|---|---|---|---|---|---|---|---|---|
| 169 Chapman Road | 769 | <i>Tilia cordata</i> | Little-leaf Linden | 51 | 5 | No | | 20% | 3x10cm branches to accommodate equipment | Injury (permit) | |

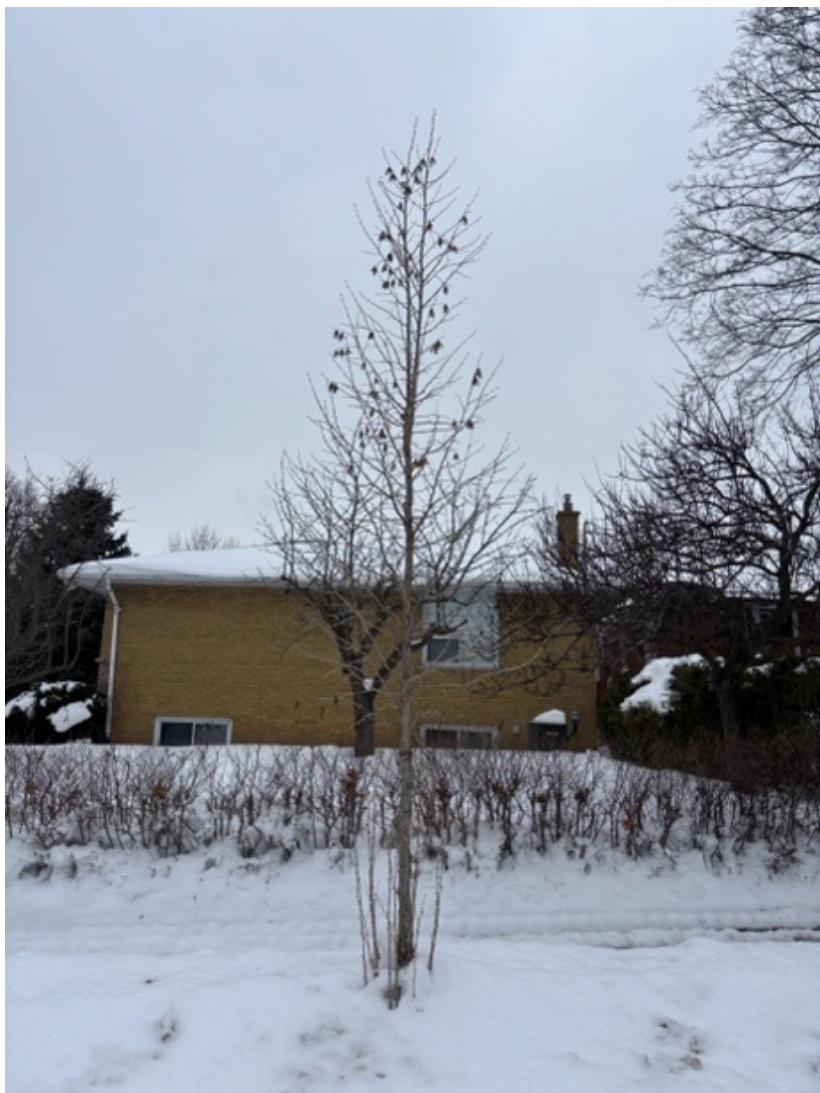
**Photo 25. Tree 14**

| Nearest Address | Tree # | Scientific Name | Common Name | DBH (cm) | Category | TPZ Encroachment | Construction Comments | Crown Pruning Required | Crown Pruning Comments | Status<br>Prune - no injury, Injury (permit), Remove (permit), Removal recommended (condition) | Required Compensation |
|---|---|---|---|---|---|---|---|---|---|---|---|
| 10 Matane Court | 14 | <i>Corylus colurna</i> | Turkish Hazel | 3 | 5 | | Proposed sanitary sewer | | | Removal (permit) | 3 |

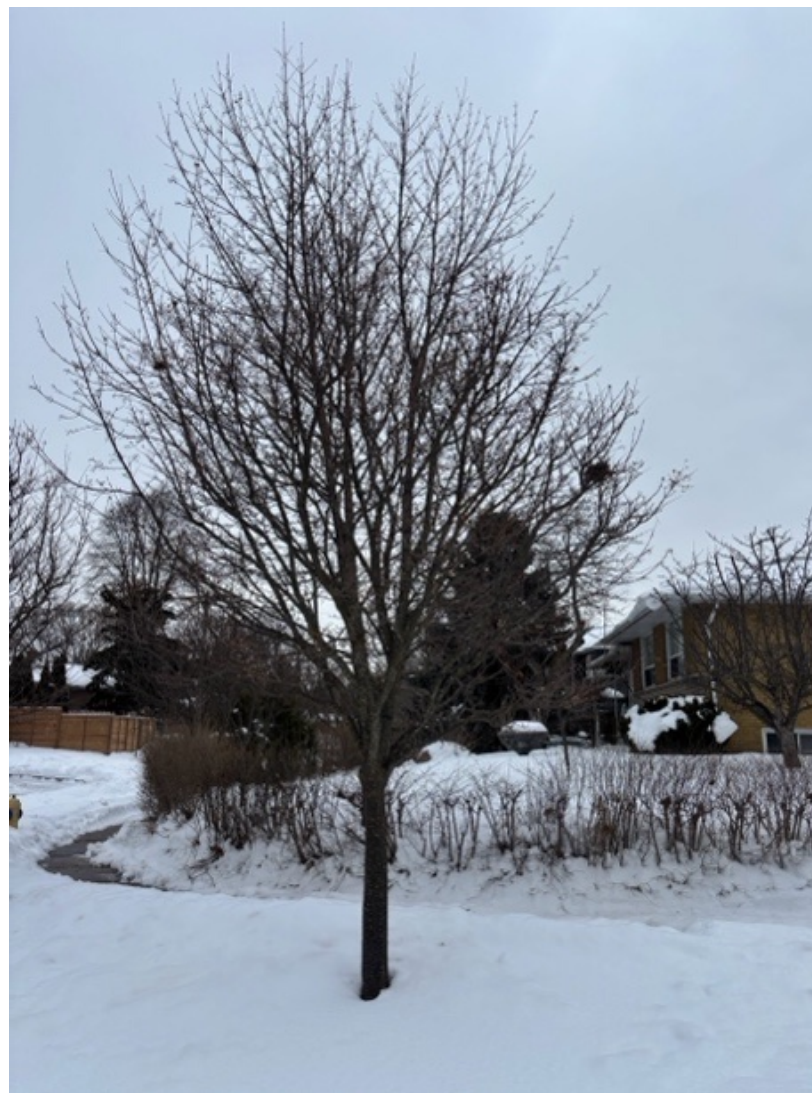
**Photo 26. Tree 10**

| Nearest Address | Tree # | Scientific Name | Common Name | DBH (cm) | Category | TPZ Encroachment | Construction Comments | Crown Pruning Required | Crown Pruning Comments | Status<br>Prune - no injury, Injury (permit), Remove (permit), Removal recommended (condition) | Required Compensation |
|---|---|---|---|---|---|---|---|---|---|---|---|
| 10 Matane Court | 10 | <i>Syringa reticulata</i> | Ivory Silk | 10 | 5 | | Proposed sanitary sewer | | | Removal (permit) | 3 |

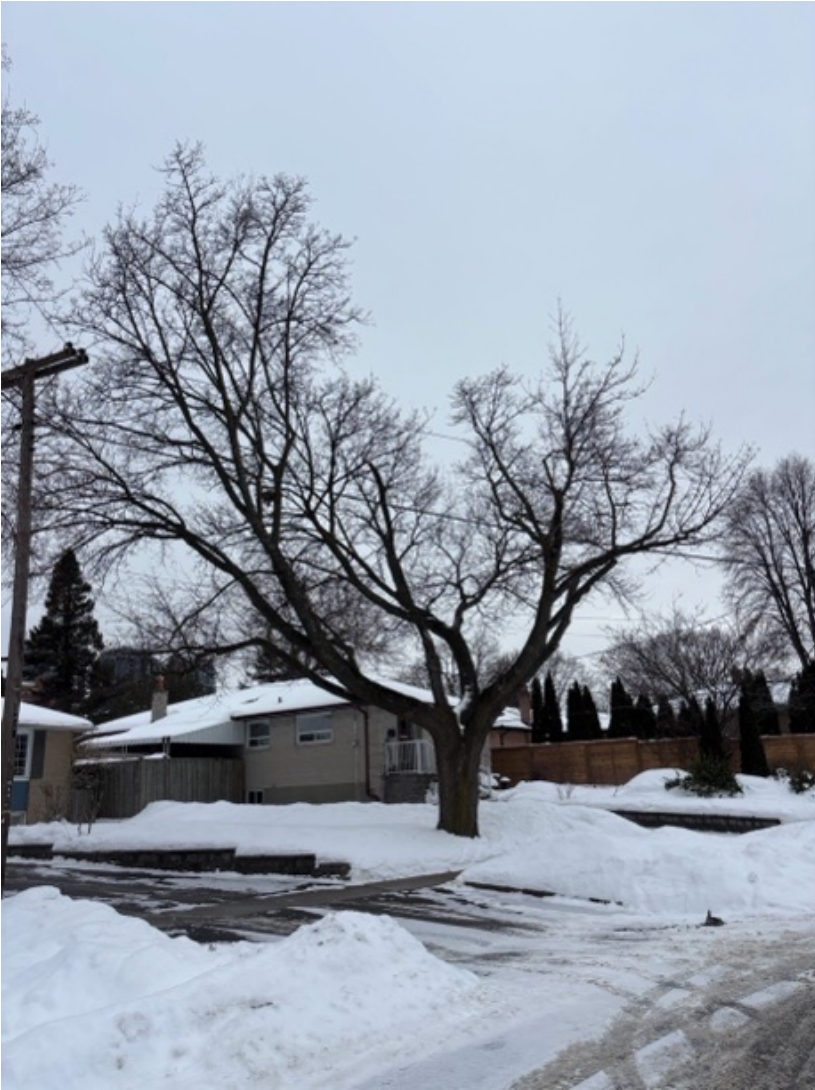
**Photo 27. Tree 34**

| Nearest Address | Tree # | Scientific Name | Common Name | DBH (cm) | Category | TPZ Encroachment | Construction Comments | Crown Pruning Required | Crown Pruning Comments | Status<br>Prune - no injury, Injury (permit), Remove (permit), Removal recommended (condition) | Required Compensation |
|---|---|---|---|---|---|---|---|---|---|---|---|
| 11 Matane Court | 34 | <i>Acer platanoides</i> | Norway Maple | 70 | 5 | No | | 5% | 1x15cm branch to accommodate equipment (tree in poor condition) | Prune - no injury | |

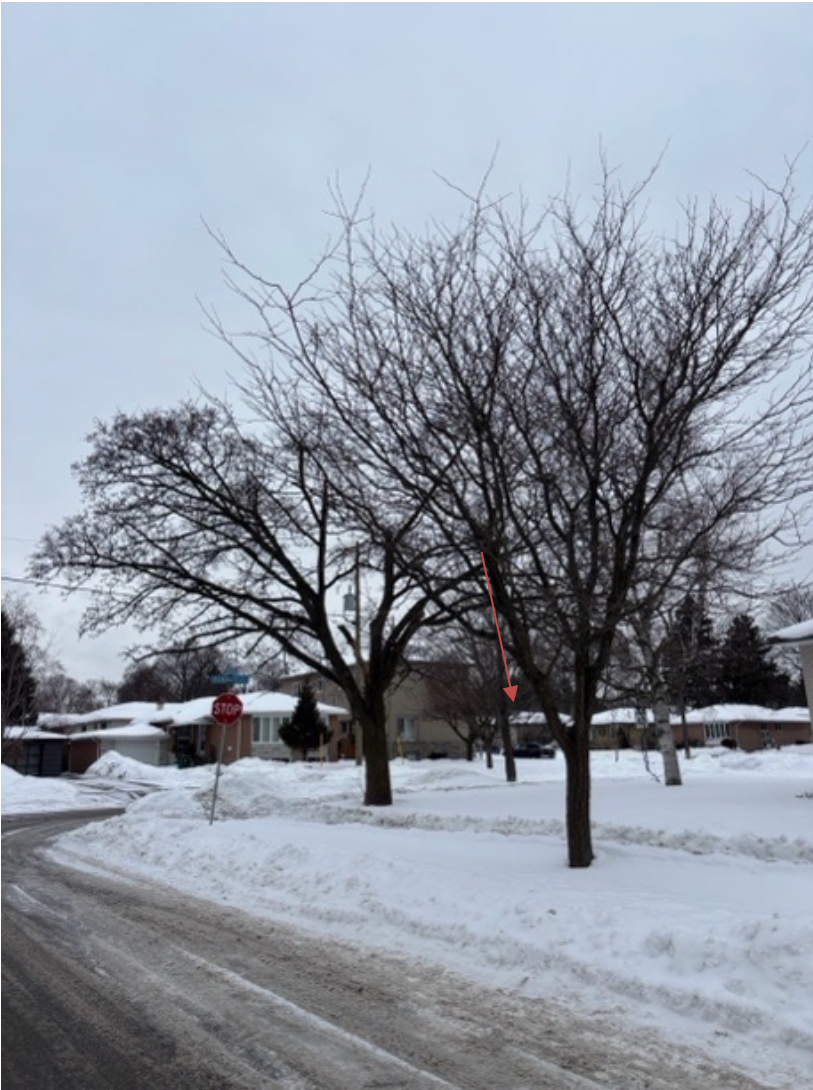
**Photo 29. Trees 890 and 891**

| Nearest Address | Tree # | Scientific Name | Common Name | DBH (cm) | Category | TPZ Encroachment | Construction Comments | Crown Pruning Required | Crown Pruning Comments | Status Prune - no injury, Injury (permit), Remove (permit), Removal recommended (condition) | Required Compensation |
|---|---|---|---|---|---|---|---|---|---|---|---|
| 2 Matane Court | 890 | <i>Gleditsia triacanthos inermis</i> | Thornless Honey Locust | 20 | 5 | No | | 20% | 4x10cm branches to accommodate equipment | Injury (permit) | |
| 2 Matane Court | 891 | <i>Acer platanoides</i> | Norway Maple | 54 | 5 | No | | <5% | 1x10 cm branch to accommodate equipment | Prune - no injury | |

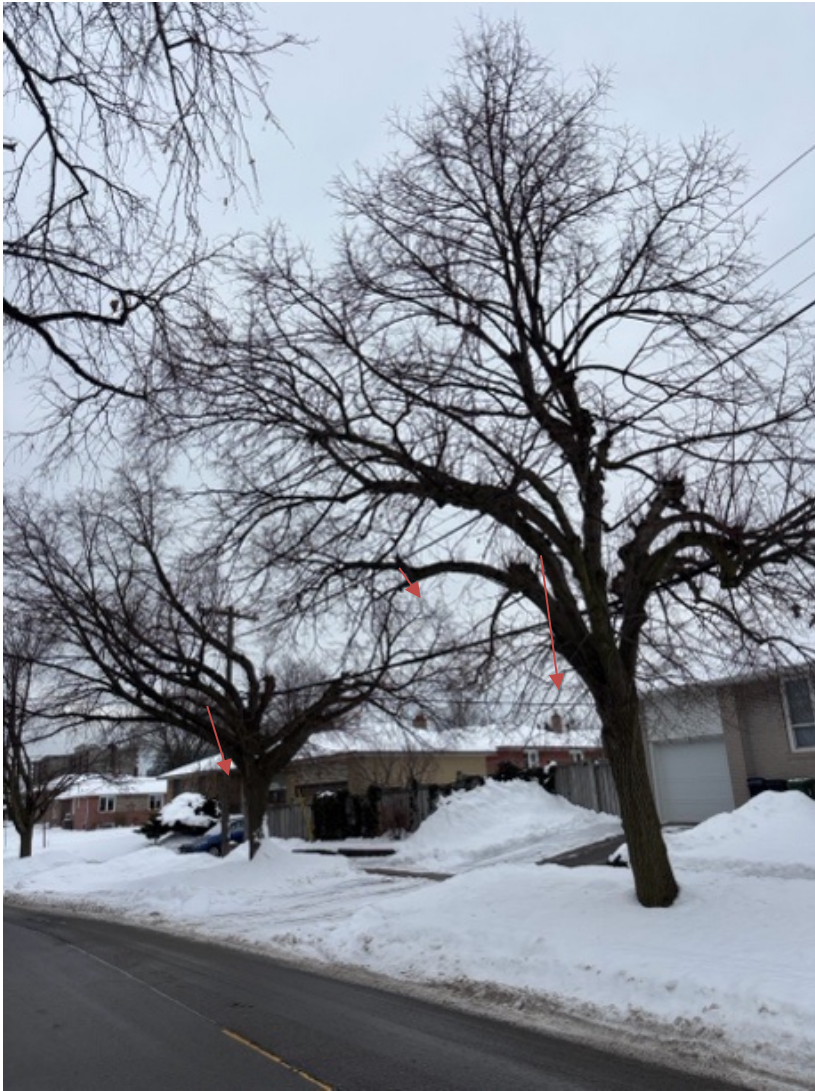
**Photo 31. Trees 765 and 763**

| Nearest Address | Tree # | Scientific Name | Common Name | DBH (cm) | Category | TPZ Encroachment | Construction Comments | Crown Pruning Required | Crown Pruning Comments | Status Prune - no injury, Injury (permit), Remove (permit), Removal recommended (condition) | Required Compensation |
|---|---|---|---|---|---|---|---|---|---|---|---|
| 16 Griggsden Avenue | 765 | <i>Tilia cordata</i> | Little-leaf Linden | 44 | 5 | No | | 25% | 2x10cm branches, 6x5cm branches to accommodate equipment | Injury (permit) | |
| 16/18 Griggsden Avenue | 763 | <i>Tilia cordata</i> | Little-leaf Linden | 44 | 5 | No | | 35% | 1x15cm branch, 3x10cm branches and 3x5cm branches to accommodate equipment | Injury (permit) | |

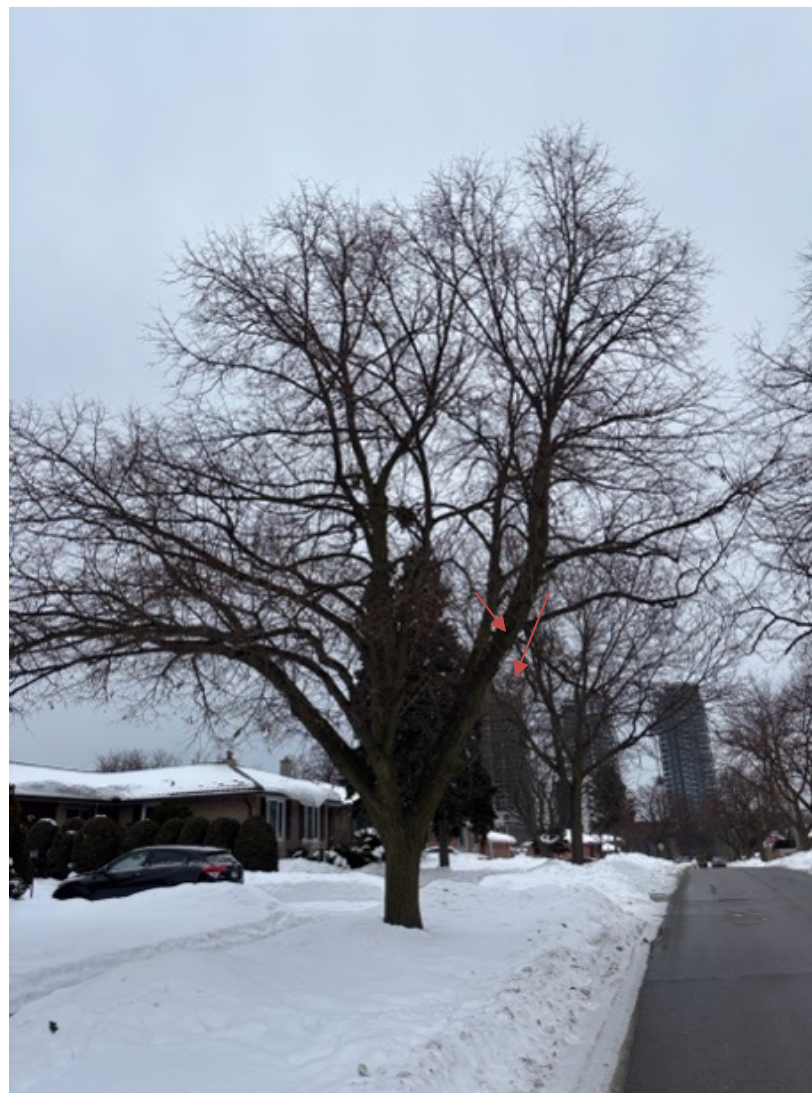
**Photo 34. Tree 1335**

| Nearest Address | Tree # | Scientific Name | Common Name | DBH (cm) | Category | TPZ Encroachment | Construction Comments | Crown Pruning Required | Crown Pruning Comments | Status Prune - no injury, Injury (permit), Remove (permit), Removal recommended (condition) | Required Compensation |
|---|---|---|---|---|---|---|---|---|---|---|---|
| 21 Griggsden Avenue | 1335 | <i>Tilia cordata</i> | Little-leaf Linden | 51 | 5 | No | | 30% | 1x12cm branch, 2x10cm branches and 1x5cm branch to accommodate equipment (tree in poor condition) | Injury (permit) | |

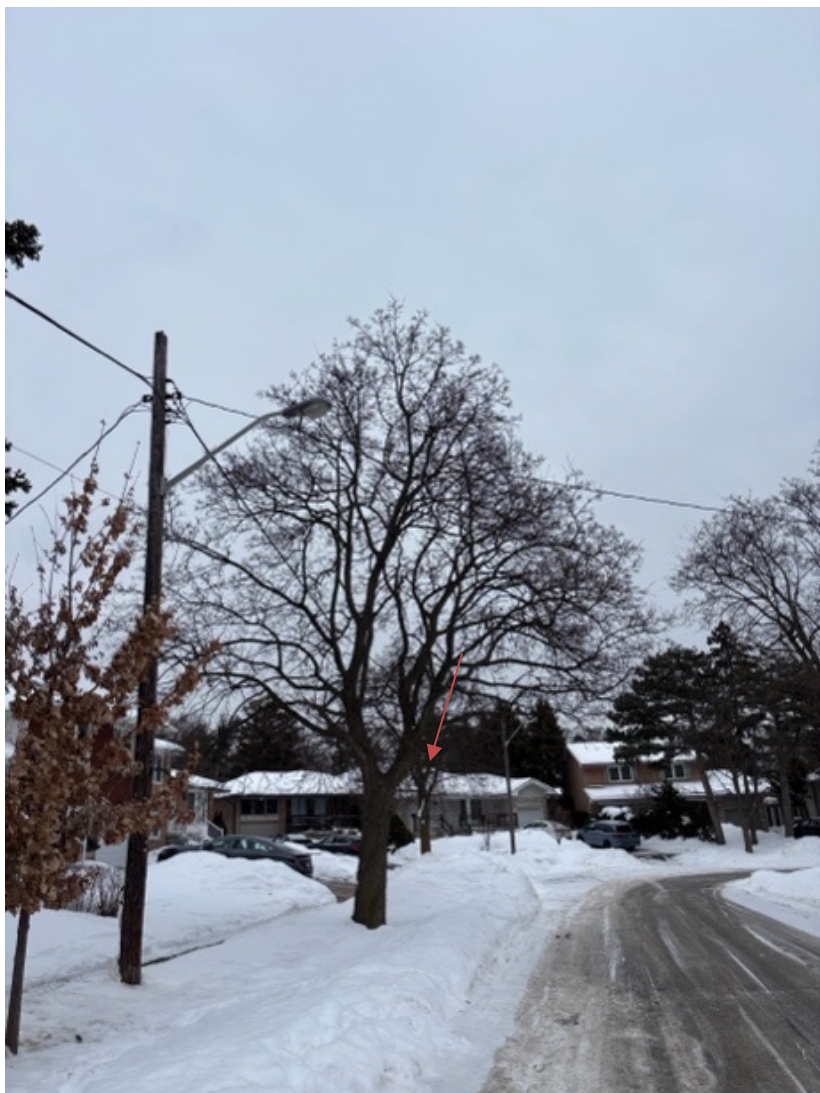
**Photo 37. Tree 355**

| Nearest Address | Tree # | Scientific Name | Common Name | DBH (cm) | Category | TPZ Encroachment | Construction Comments | Crown Pruning Required | Crown Pruning Comments | Status Prune - no injury, Injury (permit), Remove (permit), Removal recommended (condition) | Required Compensation |
|---|---|---|---|---|---|---|---|---|---|---|---|
| 14 Drury Lane | 355 | <i>Acer platanoides</i> | Norway Maple | 48 | 5 | No | | 30% | 4x10cm branches and 4x5cm branches to accommodate equipment | Injury (permit) | |

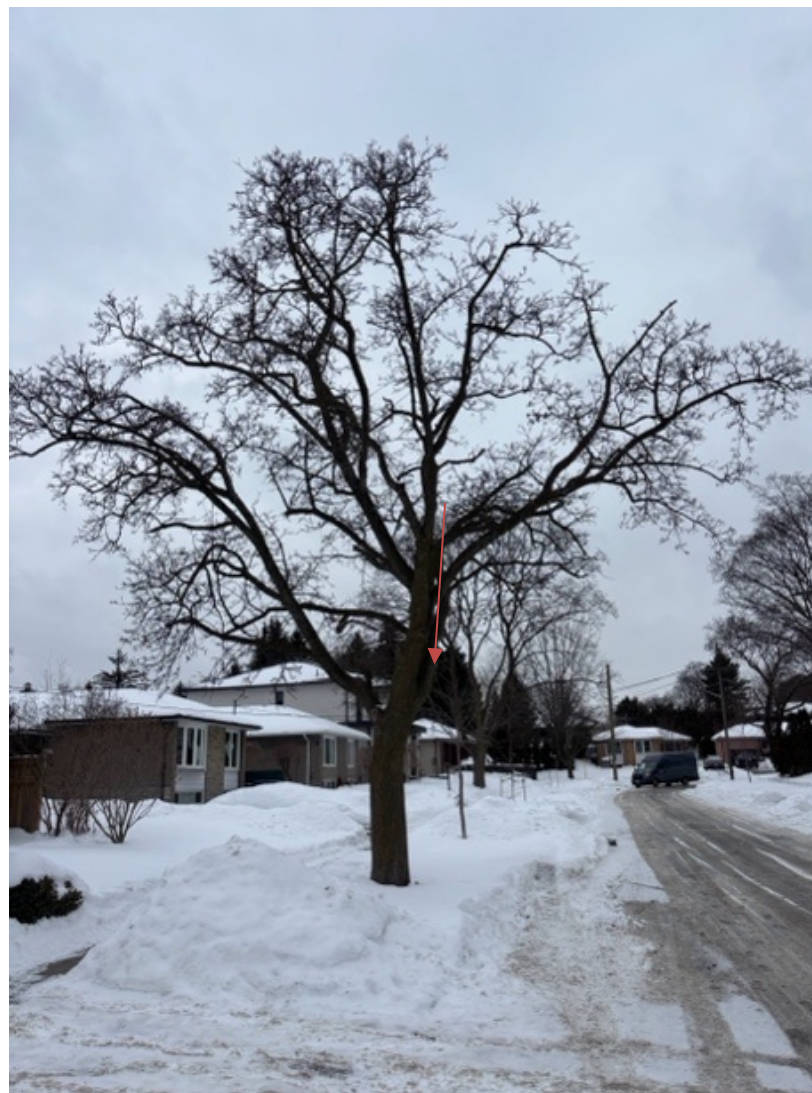
**Photo 38. Tree 1375**

| Nearest Address | Tree # | Scientific Name | Common Name | DBH (cm) | Category | TPZ Encroachment | Construction Comments | Crown Pruning Required | Crown Pruning Comments | Status Prune - no injury, Injury (permit), Remove (permit), Removal recommended (condition) | Required Compensation |
|---|---|---|---|---|---|---|---|---|---|---|---|
| 21 Drury Lane | 1375 | <i>Acer platanoides</i> | Norway Maple | 45 | 5 | No | | 35% | 1x15cm branch, 2x10cm branches to accommodate equipment | Injury (permit) | |
