# Rooted Tree Services

## ARBORIST REPORT ADDENDUM

**DATE:** 24 February 2026

**LOCATION:** Basement Flooding Protection Project, Assignment 36-01, 36-03, 36-06, 36-09, 36-11, 36-17

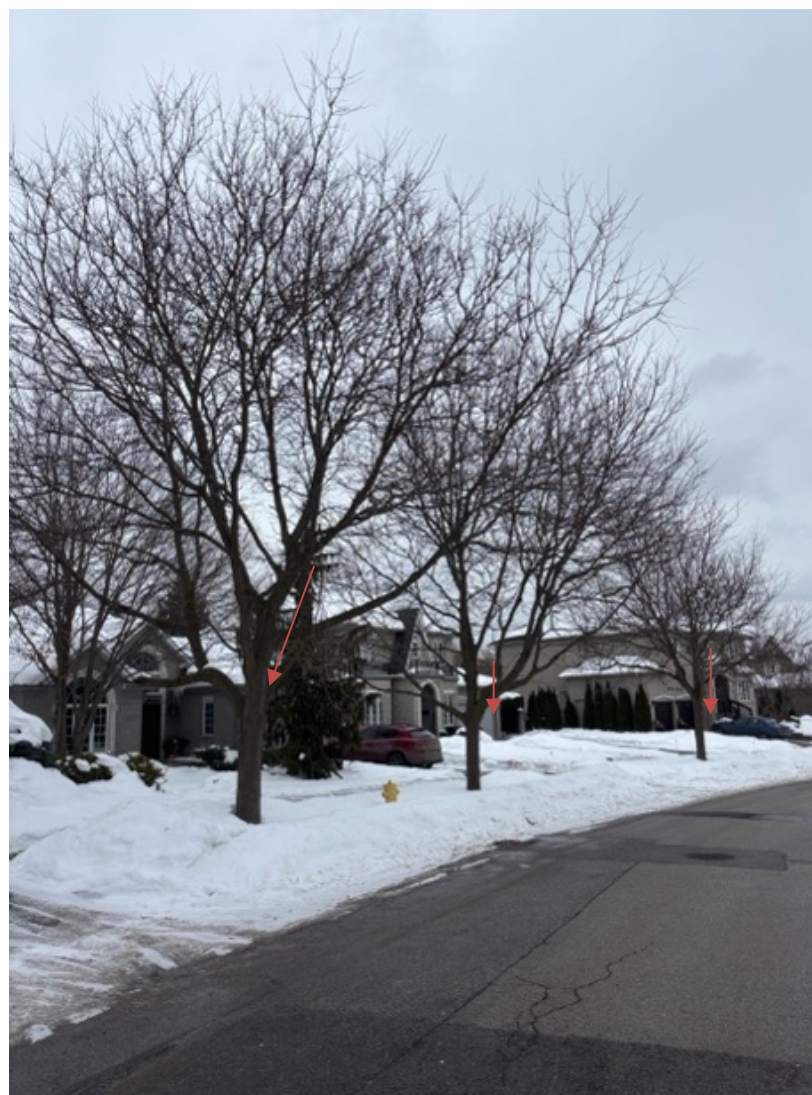
**Photo 44. Trees 1486, 1487, and 1489**

| Nearest Address | Tree # | Scientific Name | Common Name | DBH (cm) | Category | TPZ Encroachment | Construction Comments | Crown Pruning Required | Crown Pruning Comments | Status Prune - no injury, Injury (permit), Remove (permit), Removal recommended (condition) | Required Compensation |
|---|---|---|---|---|---|---|---|---|---|---|---|
| 10 Trio Avenue | 1486 | <i>Gleditsia triacanthos inermis</i> | Thornless Honey Locust | 33 | 5 | No | | 35% | 1x15cm branch and 5x10cm branches to accommodate equipment | Injury (permit) | |
| 12 Trio Avenue | 1487 | <i>Gleditsia triacanthos inermis</i> | Thornless Honey Locust | 26 | 5 | No | | 35% | 1x15cm branch and 5x10cm branches to accommodate equipment | Injury (permit) | |

| Nearest Address | Tree # | Scientific Name | Common Name | DBH (cm) | Category | TPZ Encroachment | Construction Comments | Crown Pruning Required | Crown Pruning Comments | Status Prune - no injury, Injury (permit), Remove (permit), Removal recommended (condition) | Required Compensation |
|---|---|---|---|---|---|---|---|---|---|---|---|
| 14 Trio Avenue | 1489 | <i>Gleditsia triacanthos inermis</i> | Thornless Honey Locust | 28 | 5 | No | | 20% | 1x10cm branch and 3x5cm branches to accommodate equipment | Injury (permit) | |

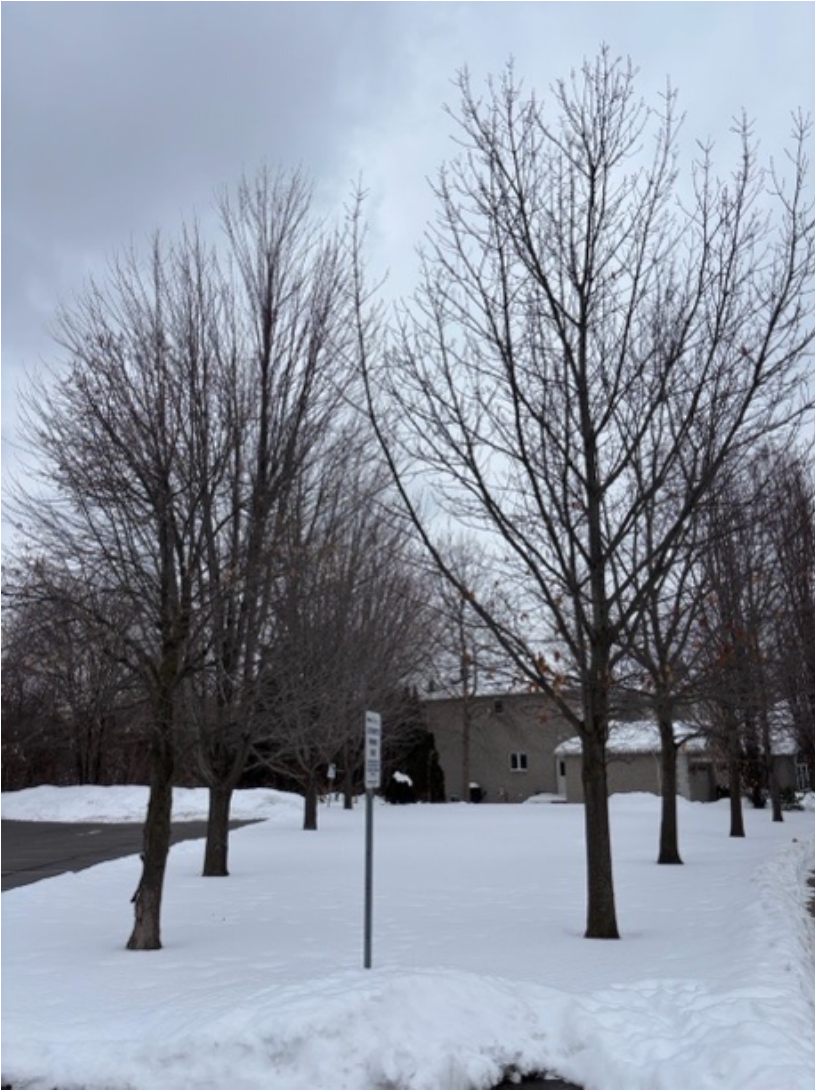
| Nearest Address | Tree # | Scientific Name | Common Name | DBH (cm) | Category | TPZ Encroachment | Construction Comments | Crown Pruning Required | Crown Pruning Comments | Status Prune - no injury, Injury (permit), Remove (permit), Removal recommended (condition) | Required Compensation |
|---|---|---|---|---|---|---|---|---|---|---|---|
| 35 The Westway | 1476 | <i>Tilia cordata</i> | Little-leaf Linden | 21 | 3 | | Proposed storm sewer | | | Removal (permit) | 3 |
| 35 The Westway | 1477 | <i>Quercus rubra</i> | Red Oak | 18 | 3 | | Proposed storm sewer | | | Removal (permit) | 3 |

**Photo 45. Trees 1476 and 1477 (foreground)**

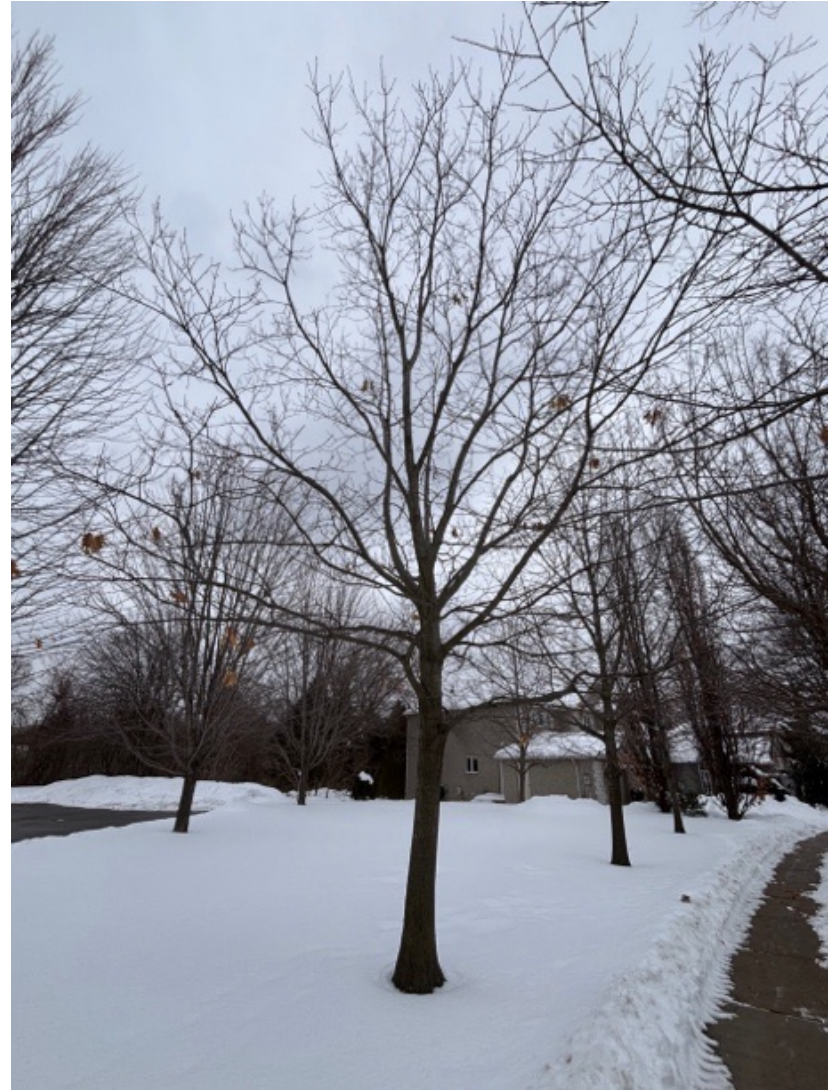
**Photo 46. Tree 1479**

| Nearest Address | Tree # | Scientific Name | Common Name | DBH (cm) | Category | TPZ Encroachment | Construction Comments | Crown Pruning Required | Crown Pruning Comments | Status Prune - no injury, Injury (permit), Remove (permit), Removal recommended (condition) | Required Compensation |
|---|---|---|---|---|---|---|---|---|---|---|---|
| 35 The Westway | 1479 | <i>Quercus rubra</i> | Red Oak | 18 | 3 | | Proposed storm sewer | | | Removal (permit) | 3 |

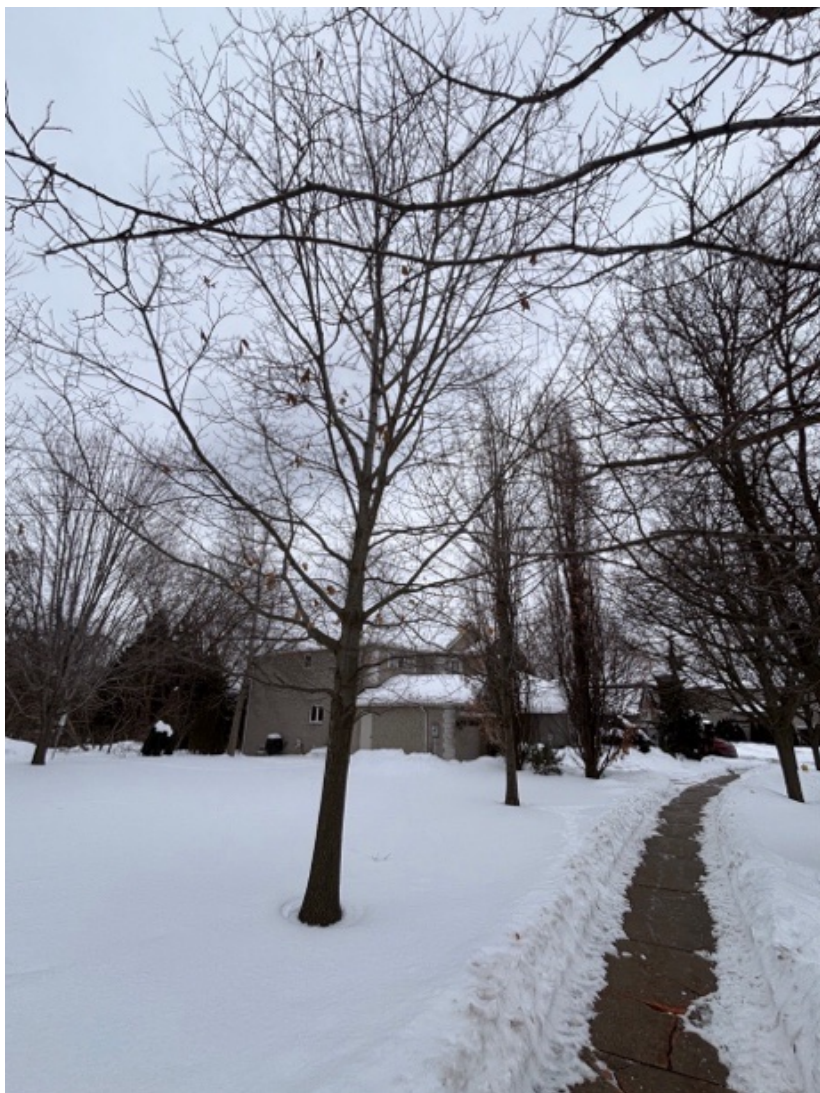
| Nearest Address | Tree # | Scientific Name | Common Name | DBH (cm) | Category | TPZ Encroachment | Construction Comments | Crown Pruning Required | Crown Pruning Comments | Status Prune - no injury, Injury (permit), Remove (permit), Removal recommended (condition) | Required Compensation |
|---|---|---|---|---|---|---|---|---|---|---|---|
| 35 The Westway | 1481 | <i>Quercus rubra</i> | Red Oak | 17 | 3 | | Proposed storm sewer | | | Removal (permit) | 3 |
| 35 The Westway | 1483 | <i>Quercus rubra</i> | Red Oak | 14 | 3 | | Proposed storm sewer | | | Removal (permit) | 3 |

**Photo 47. Trees 1481 and 1483 (left and right of centre)**

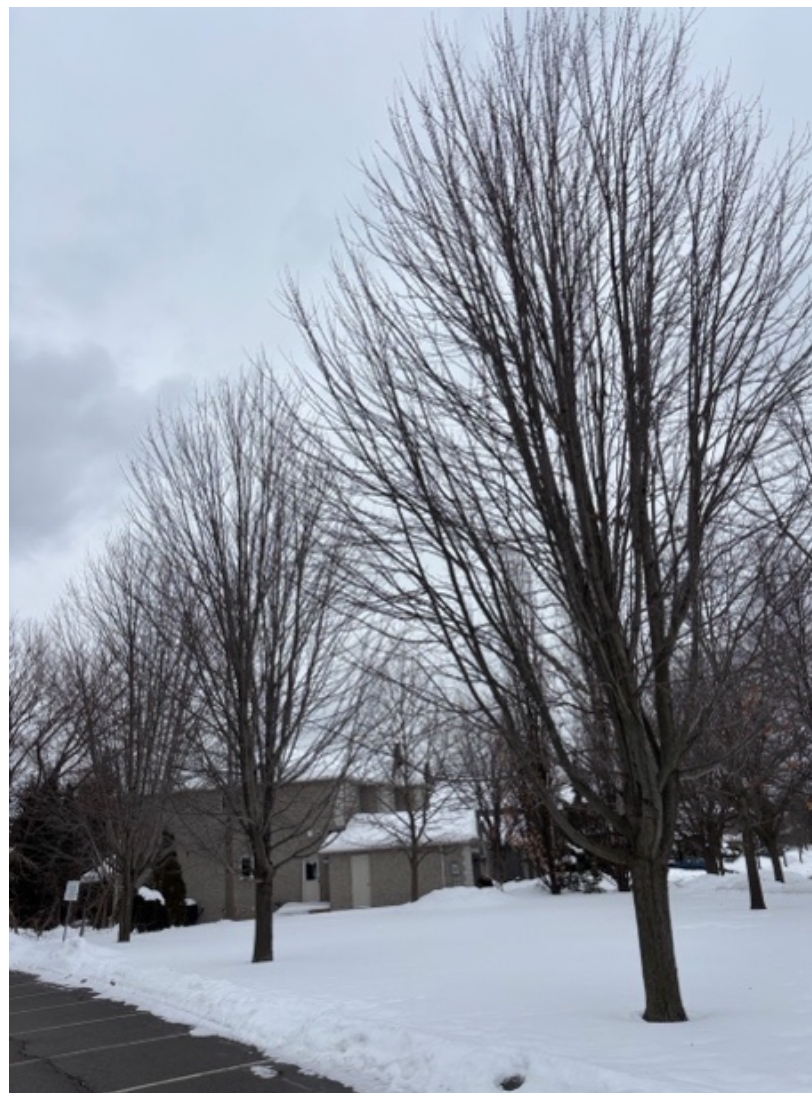
**Photo 48. Trees A-C**

| Nearest Address | Tree # | Scientific Name | Common Name | DBH (cm) | Category | TPZ Encroachment | Construction Comments | Crown Pruning Required | Crown Pruning Comments | Status Prune - no injury, Injury (permit), Remove (permit), Removal recommended (condition) | Required Compensation |
|---|---|---|---|---|---|---|---|---|---|---|---|
| 35 The Westway | A | <i>Acer x freemanii</i> | Freeman Maple | 16 | 3 | | Proposed storm sewer | | | Removal (permit) | 3 |
| 35 The Westway | B | <i>Acer x freemanii</i> | Freeman Maple | 17 | 3 | | Proposed storm sewer | | | Removal (permit) | 3 |
| 35 The Westway | C | <i>Acer x freemanii</i> | Freeman Maple | 16 | 3 | | Proposed storm sewer | | | Removal (permit) | 3 |

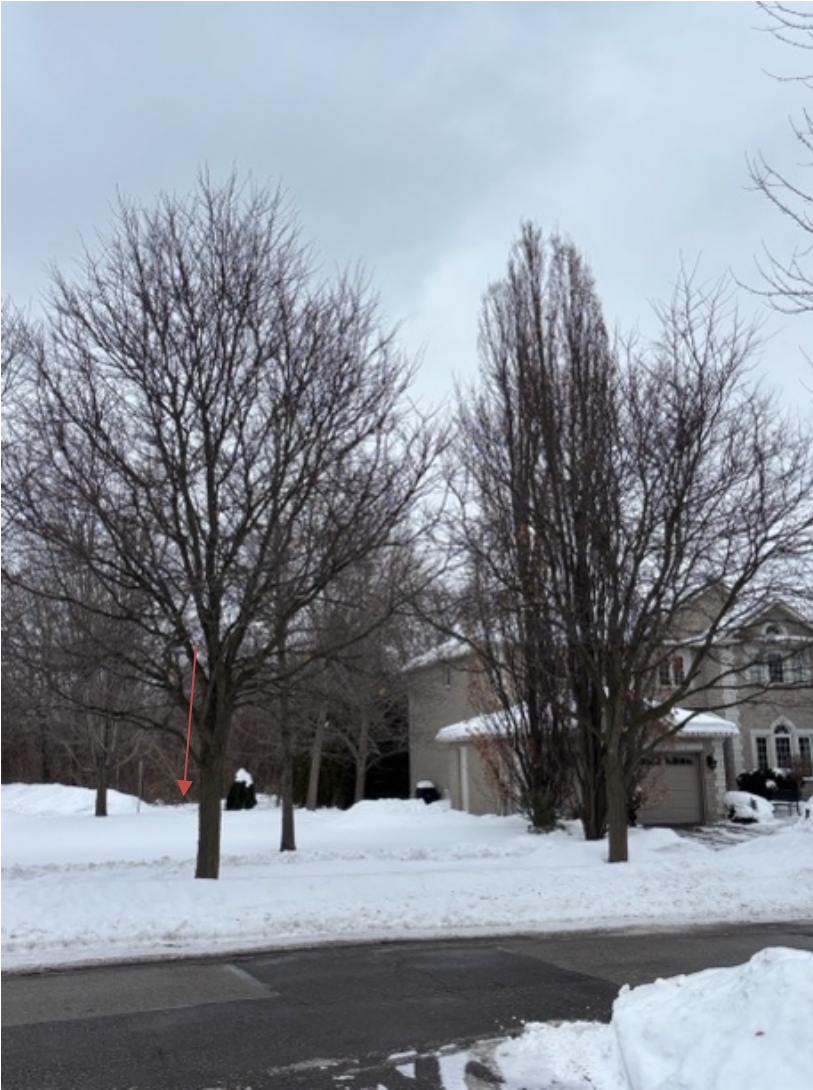
**Photo 49. Trees 1482 and 1484**

| Nearest Address | Tree # | Scientific Name | Common Name | DBH (cm) | Category | TPZ Encroachment | Construction Comments | Crown Pruning Required | Crown Pruning Comments | Status Prune - no injury, Injury (permit), Remove (permit), Removal recommended (condition) | Required Compensation |
|---|---|---|---|---|---|---|---|---|---|---|---|
| 10 Trio Avenue | 1482 | <i>Gleditsia triacanthos inermis</i> | Thornless Honey Locust | 24 | 5 | No | | 25% | 4x10cm branches and 8x3cm branches to accommodate equipment | Injury (permit) | |
| 10 Trio Avenue | 1484 | <i>Gleditsia triacanthos inermis</i> | Thornless Honey Locust | 26 | 5 | No | Proposed storm sewer | | | Removal (permit) | 3 |

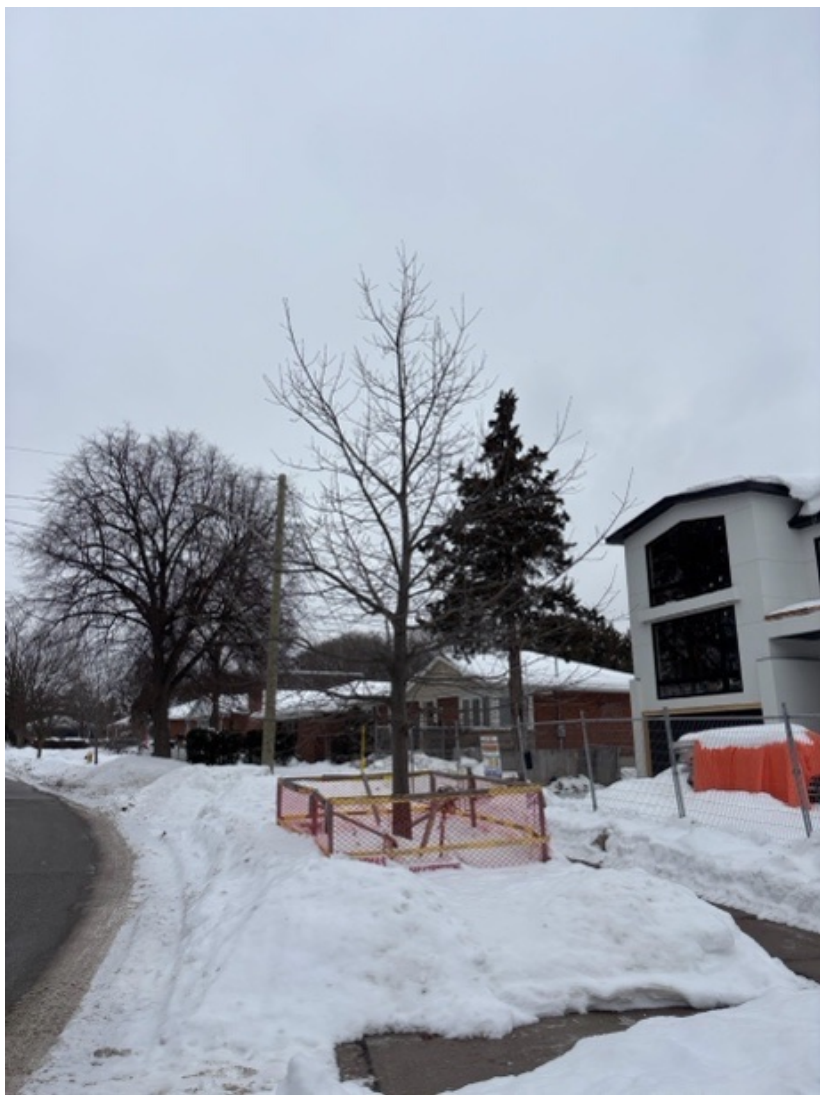
Photo 51. Tree 1468

| Nearest Address | Tree # | Scientific Name | Common Name | DBH (cm) | Category | TPZ Encroachment | Construction Comments | Crown Pruning Required | Crown Pruning Comments | Status Prune - no injury, Injury (permit), Remove (permit), Removal recommended (condition) | Required Compensation |
|---|---|---|---|---|---|---|---|---|---|---|---|
| 51 Westroyal Road | 1468 | <i>Quercus rubra</i> | Red Oak | 13 | 5 | No | Proposed storm sewer | | | Removal (permit) | 3 |

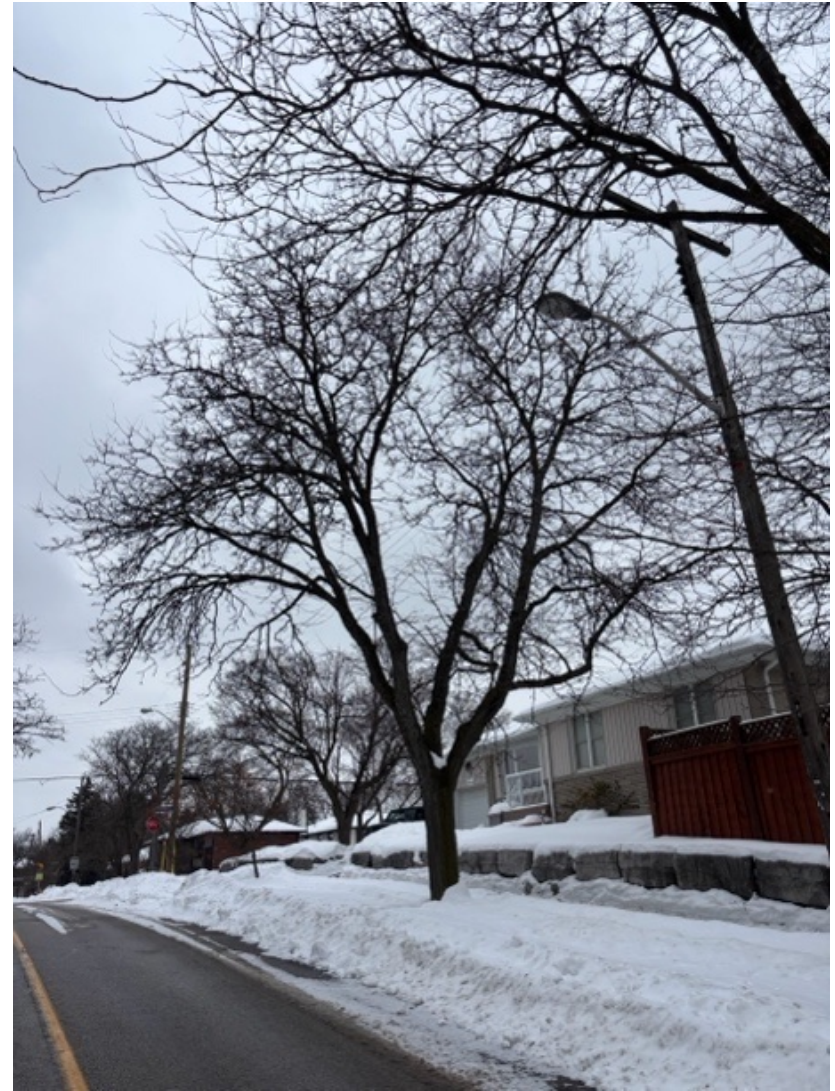
**Photo 54. Tree 1715C**

| Nearest Address | Tree # | Scientific Name | Common Name | DBH (cm) | Category | TPZ Encroachment | Construction Comments | Crown Pruning Required | Crown Pruning Comments | Status Prune - no injury, Injury (permit), Remove (permit), Removal recommended (condition) | Required Compensation |
|---|---|---|---|---|---|---|---|---|---|---|---|
| 4 Korol Avenue | 1715 C | <i>Gleditsia triacanthos inermis</i> | Thornless Honey Locust | 50 | 5 | No | Proposed entry pit | | | Removal (permit) | 3 |

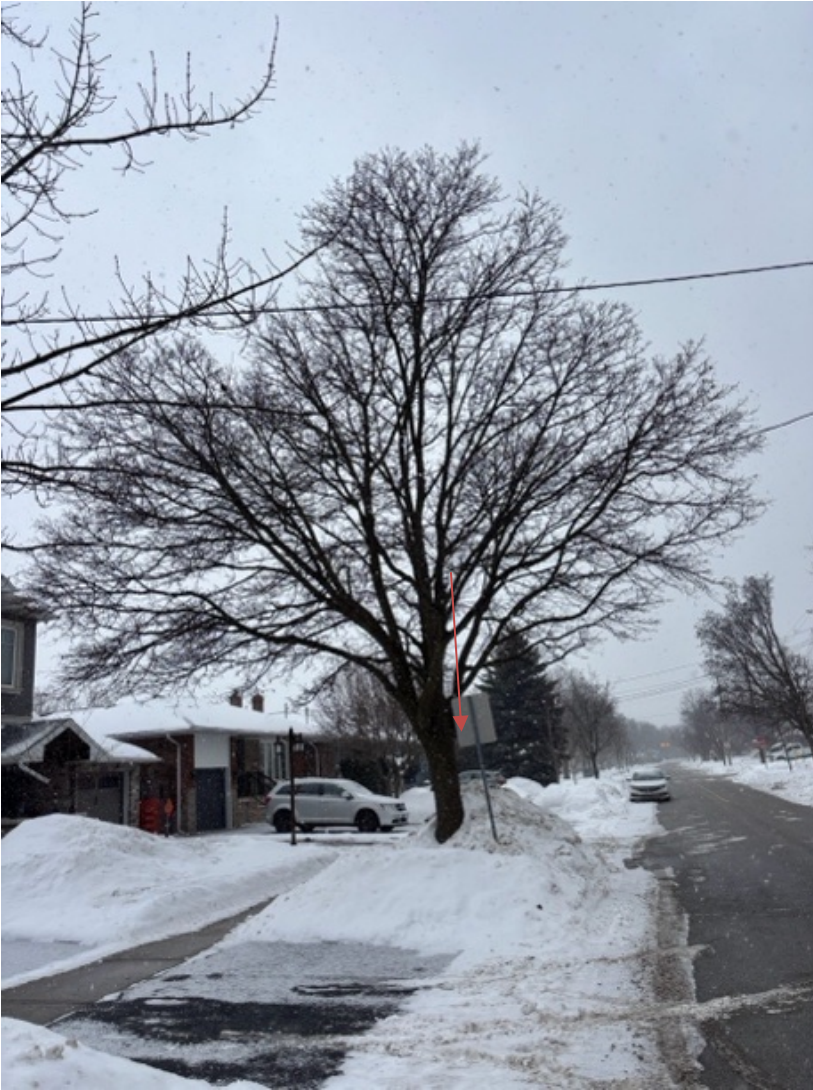
**Photo 57. Tree 2614**

| Nearest Address | Tree # | Scientific Name | Common Name | DBH (cm) | Category | TPZ Encroachment | Construction Comments | Crown Pruning Required | Crown Pruning Comments | Status Prune - no injury, Injury (permit), Remove (permit), Removal recommended (condition) | Required Compensation |
|---|---|---|---|---|---|---|---|---|---|---|---|
| 41 Poynter Drive | 2614 | <i>Acer platanoides</i> | Norway Maple | 40 | 5 | No | | 25% | 1x10cm branch and 5x5cm branches to accommodate equipment | Injury (permit) | |

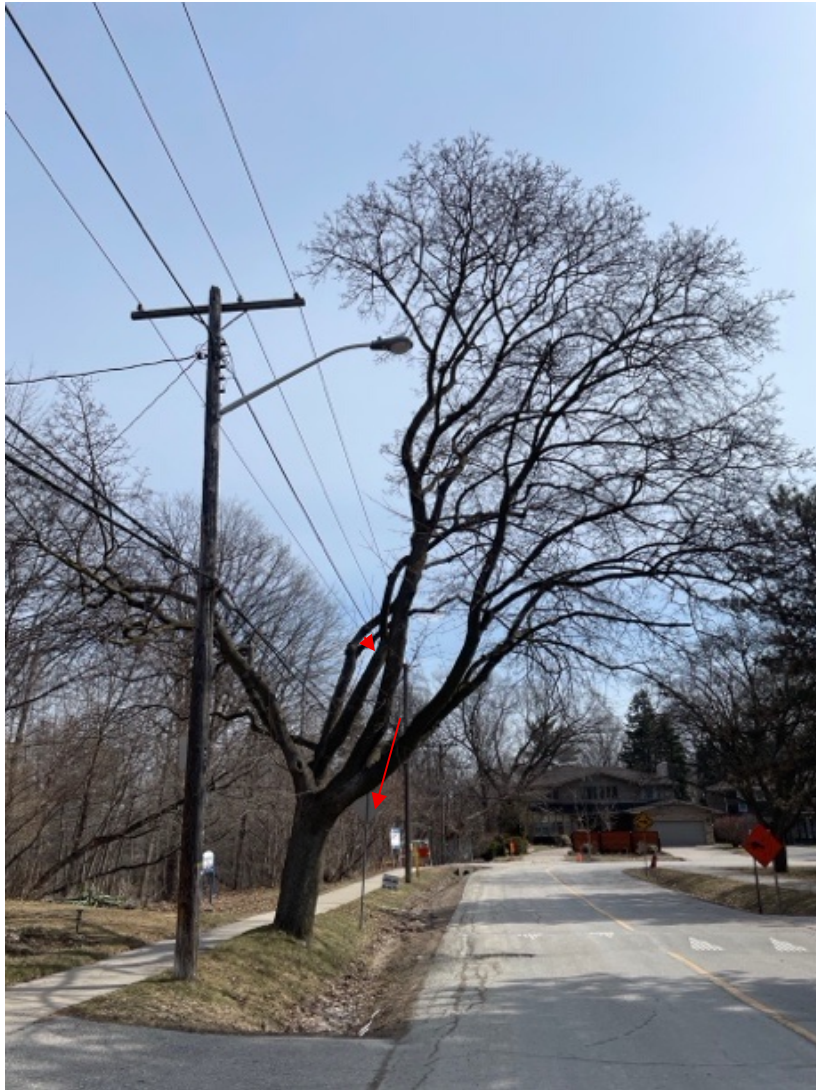
| Nearest Address | Tree # | Scientific Name | Common Name | DBH (cm) | Category | TPZ Encroachment | Construction Comments | Crown Pruning Required | Crown Pruning Comments | Status Prune - no injury, Injury (permit), Remove (permit), Removal recommended (condition) | Required Compensation |
|---|---|---|---|---|---|---|---|---|---|---|---|
| 70 Chapman Road | 470 | <i>Acer platanoides</i> | Norway Maple | 66 | 5 | No | | 35% | 2x20cm branches and 2x10cm branches to accommodate equipment (tree in poor condition) | Injury (permit) | |

**Photo 63. Tree 470 Showing potential pruning damage in addition to existing damage caused by pruning for utility line access**

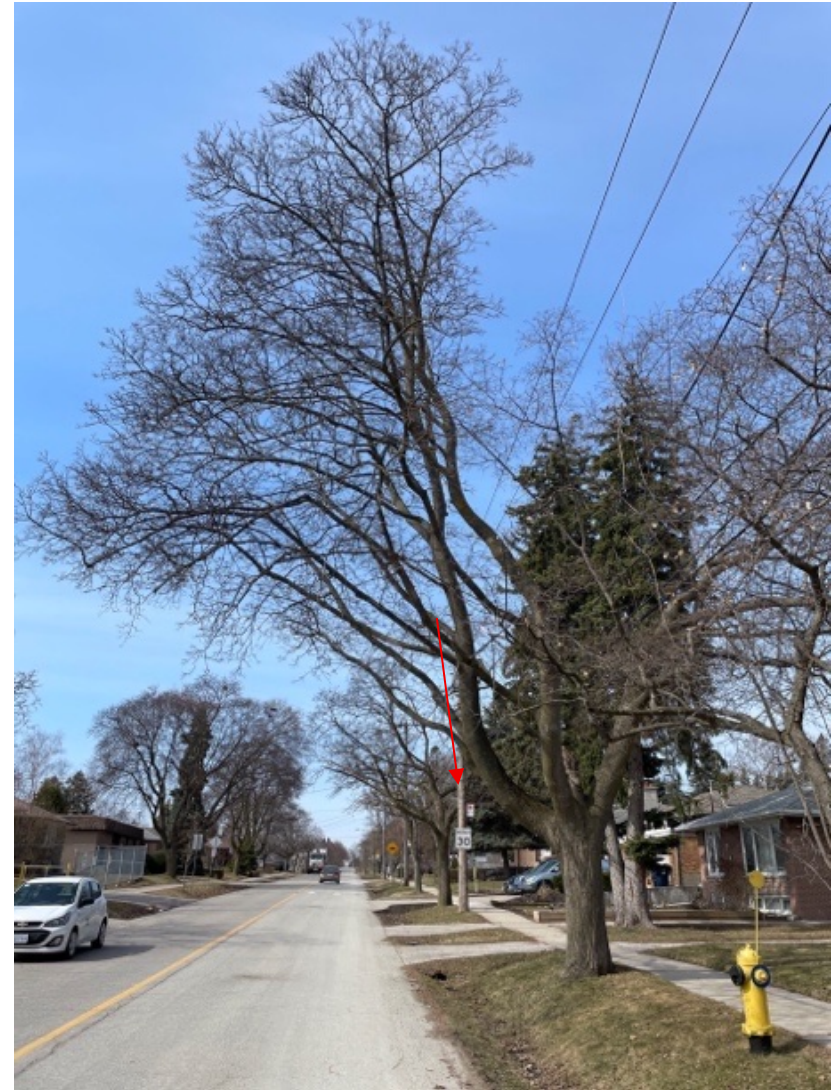
| Nearest Address | Tree # | Scientific Name | Common Name | DBH (cm) | Category | TPZ Encroachment | Construction Comments | Crown Pruning Required | Crown Pruning Comments | Status Prune - no injury, Injury (permit), Remove (permit), Removal recommended (condition) | Required Compensation |
|---|---|---|---|---|---|---|---|---|---|---|---|
| 76 Chapman Road | 459 | <i>Acer platanoides</i> | Norway Maple | 62 | 5 | No | | 30% | 1x15cm branch, 1x10cm branch and 3x8cm branches to accommodate equipment | Injury (permit) | |

**Photo 64. Tree 459 Showing potential pruning damage in addition to existing damage caused by pruning for utility line access**
