# **Rooted Tree Services**

## **ARBORIST REPORT ADDENDUM**

**DATE:** 7 August 2025, revised 26 November 2025

**LOCATION:** Woodborough Park (Contract No. 23ECS-MI-03FS)

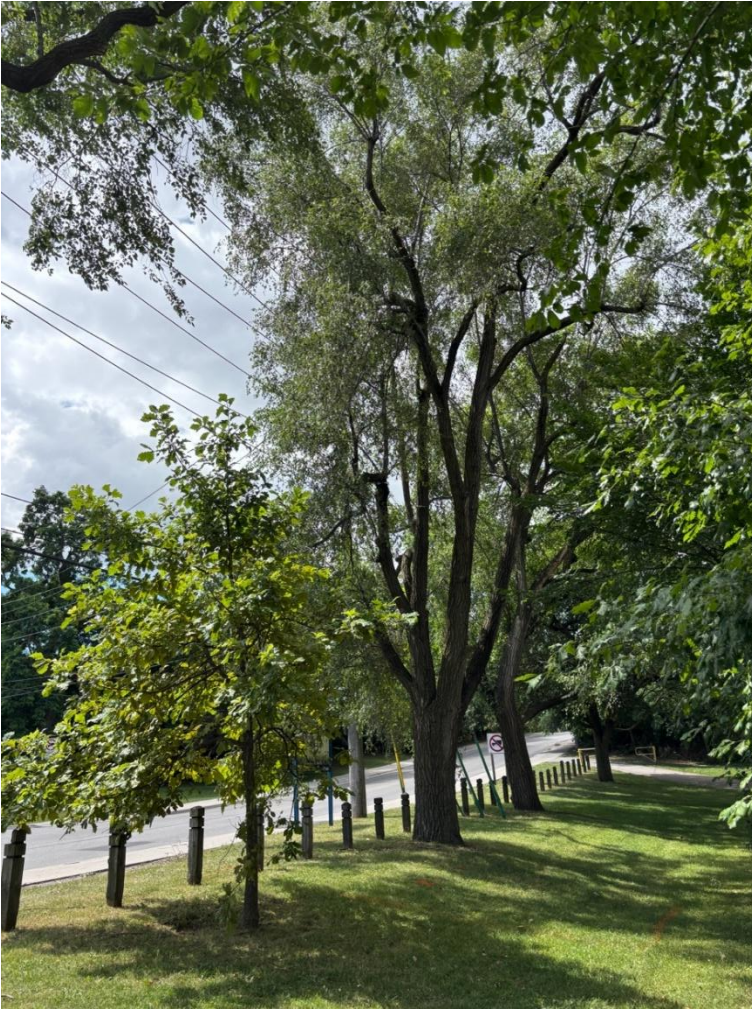
The removal of two (2) trees, Trees 'Wood BB' and 4345 will require removal to accommodate manhole replacement. A permit will be required for the removal of these trees.

| Nearest Address | Tree # | Scientific Name | Common Name | DBH (cm) | Cat. | MTPZ (m) | TPZ Encroachment | Construction Comments | Crown Pruning Required | Crown Pruning Comments | Status<br>Prune - no injury, Injury (permit), Remove (permit), Removal recommended (condition) | Required Compensation |
|---|---|---|---|---|---|---|---|---|---|---|---|---|
| Woodborough Park | Wood BB | <i>Quercus bicolor</i> | Swamp White Oak | 10.5 | 4 | 3.6 | Yes | Manhole Replacement | | | Remove (permit) | 1 |
| Woodborough Park | 4345 | <i>Ulmus pumila</i> | Siberian elm | 73 | 4 | 9.6 | Yes | Manhole Replacement | | | Remove (permit) | 7 |

**Photo 1. Trees “Wood BB” (left) and 4345 (centre), view looking southwest**

Trees are protected by the Ravine and Natural Feature Protection By-law and will be compensated based on the City's Ravine Compensation Pilot. A total of 8 trees will need to be planted to compensate for the proposed tree removals and injuries. The trees should be planted in the spring or fall immediately following construction completion. Trees should be watered during periods of drought in the growing season for two years following installation. Refer to Figure 1 for proposed locations of replacement trees, the planting schedule, and planting detail.

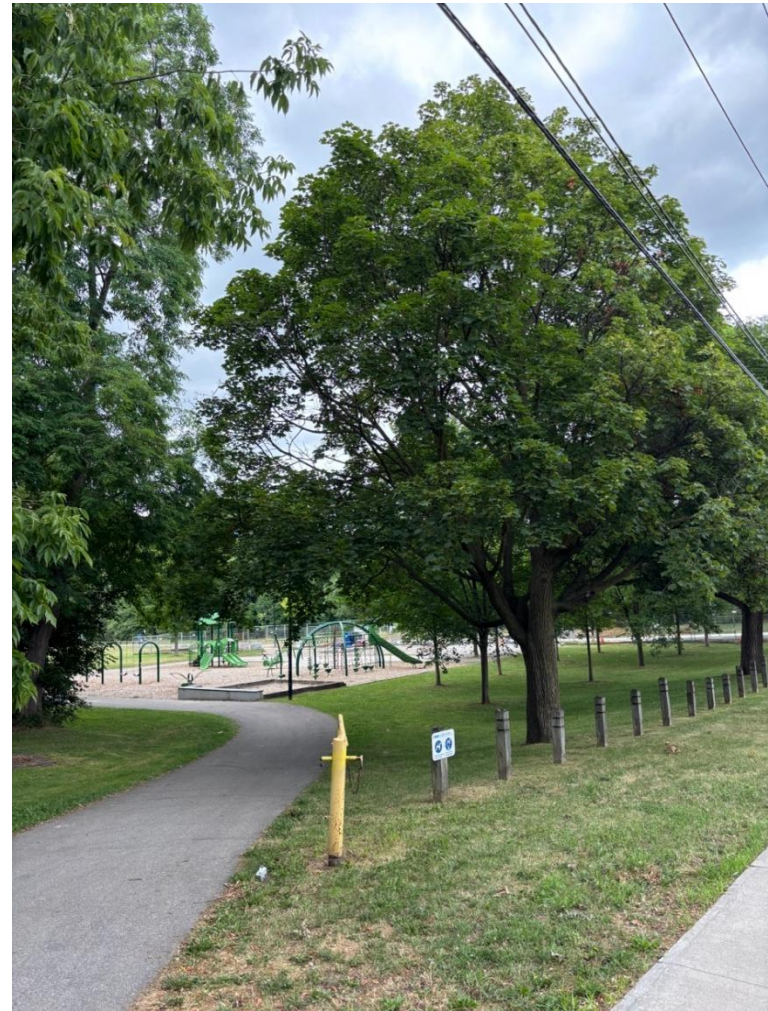
| Nearest Address | Tree # | Scientific Name | Common Name | DBH (cm) | Cat. | MTPZ (m) | TPZ Encroachment | Construction Comments | Crown Pruning Required | Crown Pruning Comments | Status<br>Prune - no injury, Injury (permit), Remove (permit), Removal recommended (condition) | Required Compensation |
|---|---|---|---|---|---|---|---|---|---|---|---|---|
| Woodborough Park | 4775 | <i>Quercus bicolor</i> | Swamp White Oak | ~11 | 4 | 3.6 | No | Manhole Replacement | Approx. 10% of crown | Prune 2x2cm branches for equipment access | Prune - No Injury | |
| Woodborough Park | 4346 | <i>Acer platanooides</i> | Norway Maple | 57 | 4 | 7.2 | No | Accommodation for use of heavy equipment on-site | Up to 20% of crown | Prune ~2-3 x 5cm branches for equipment access | Prune - No Injury | |

**Photo 2. Trees 4346 (centre right), 4003, 4775, (background right), view looking northeast**

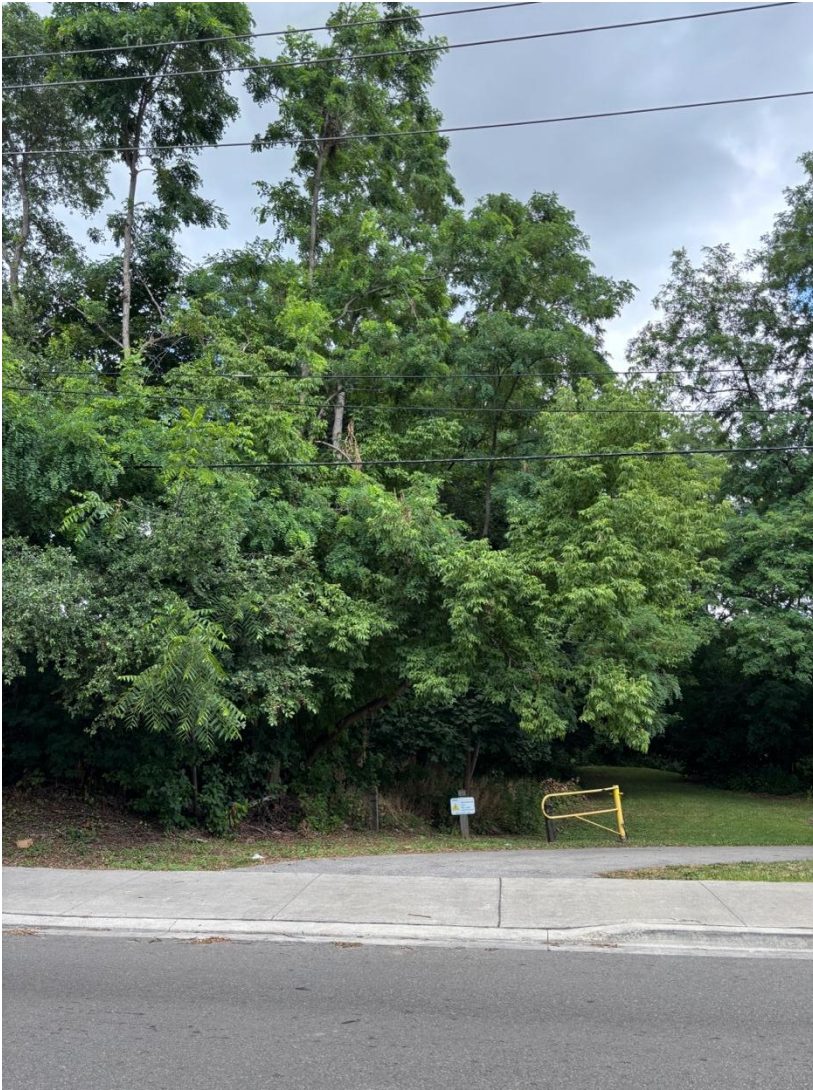
| Nearest Address | Tree # | Scientific Name | Common Name | DBH (cm) | Cat. | MTPZ (m) | TPZ Encroachment | Construction Comments | Crown Pruning Required | Crown Pruning Comments | Status<br>Prune - no injury, Injury (permit), Remove (permit), Removal recommended (condition) | Required Compensation |
|---|---|---|---|---|---|---|---|---|---|---|---|---|
| Woodborough Park | 4203 | <i>Acer Negundo</i> | Manitoba Maple | 21,23 [31] | 4 | 4.8 | No | | | | Preserve | |

**Photo 3. Tree 4203 (right centre), view looking northwest**

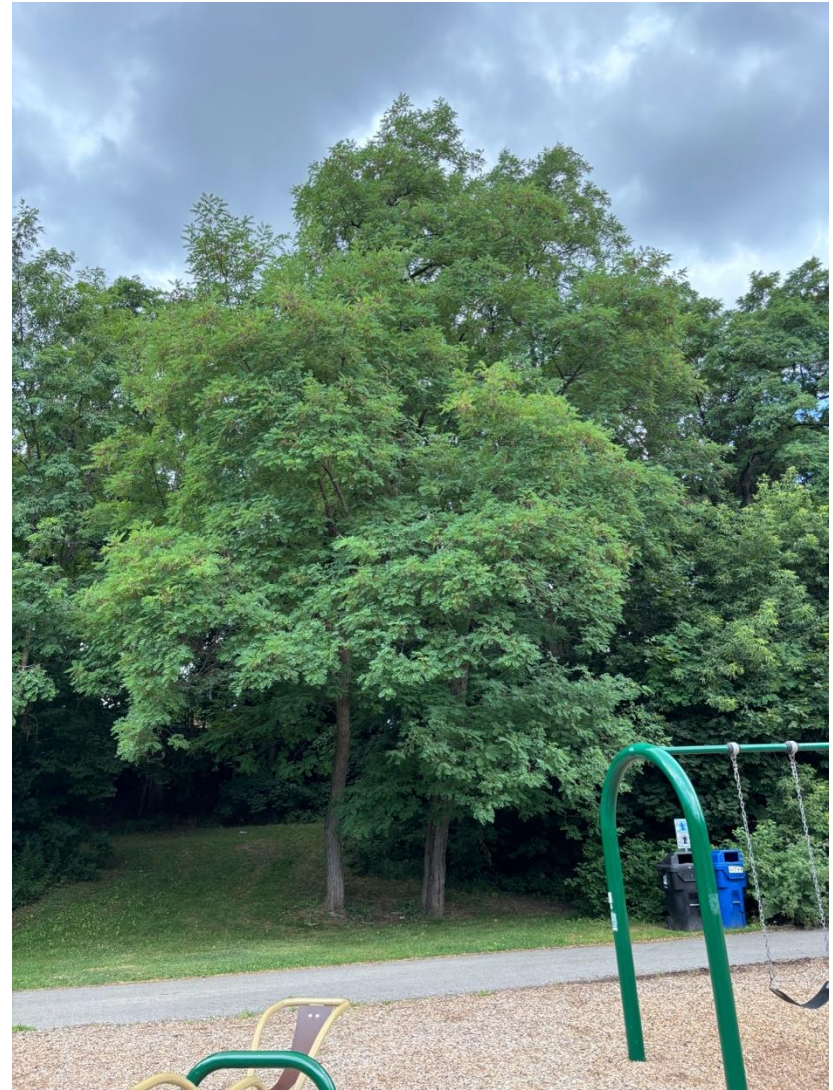
| Nearest Address | Tree # | Scientific Name | Common Name | DBH (cm) | Cat. | MTPZ (m) | TPZ Encroachment | Construction Comments | Crown Pruning Required | Crown Pruning Comments | Status<br>Prune - no injury, Injury (permit), Remove (permit), Removal recommended (condition) | Required Compensation |
|---|---|---|---|---|---|---|---|---|---|---|---|---|
| Woodborough Park | 4016 | <i>Robinia pseudoacacia</i> | Black Locust | 33 | 4 | 4.8 | No | Accommodation for use of heavy equipment on-site | Approx. 5% of Crown | Prune 1x10cm branch for equipment access | Prune - No Injury | |
| Woodborough Park | 4015 | <i>Robinia pseudoacacia</i> | Black Locust | 47 | 4 | 6.0 | No | Accommodation for use of heavy equipment on-site | Approx. 5% of Crown | Prune 1x10cm branch for equipment access | Prune - No Injury | |

**Photo 4. Trees 4015 and 4016 (left to right), view looking southwest**

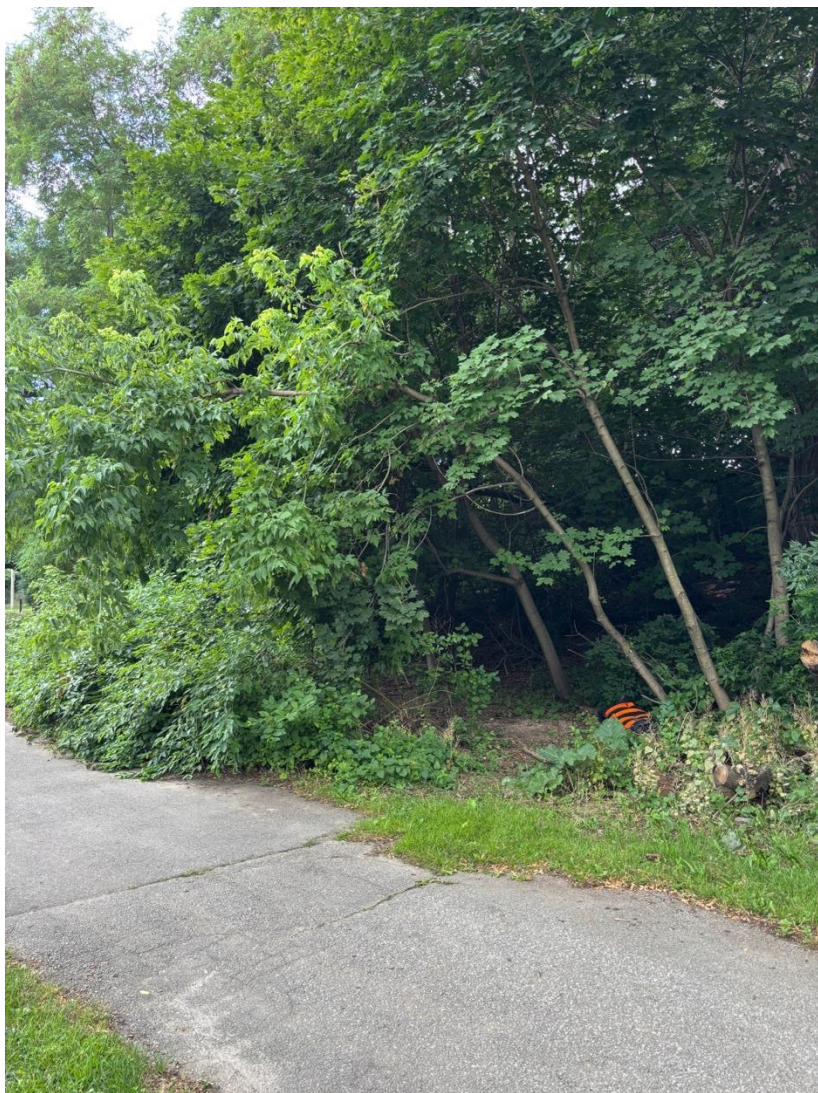
| Nearest Address | Tree # | Scientific Name | Common Name | DBH (cm) | Cat. | MTPZ (m) | TPZ Encroachment | Construction Comments | Crown Pruning Required | Crown Pruning Comments | Status<br>Prune - no injury, Injury (permit), Remove (permit), Removal recommended (condition) | Required Compensation |
|---|---|---|---|---|---|---|---|---|---|---|---|---|
| Woodborough Park | 4029 | <i>Acer Negundo</i> | Manitoba Maple | 10.5 | 4 | 3.6 | No | Accommodation for use of heavy equipment on-site | Up to 20% of crown | Prune 2-3x2cm branches for equipment access | Prune - No Injury | |

**Photo 5. Tree 4029 (right of centre), view looking south**

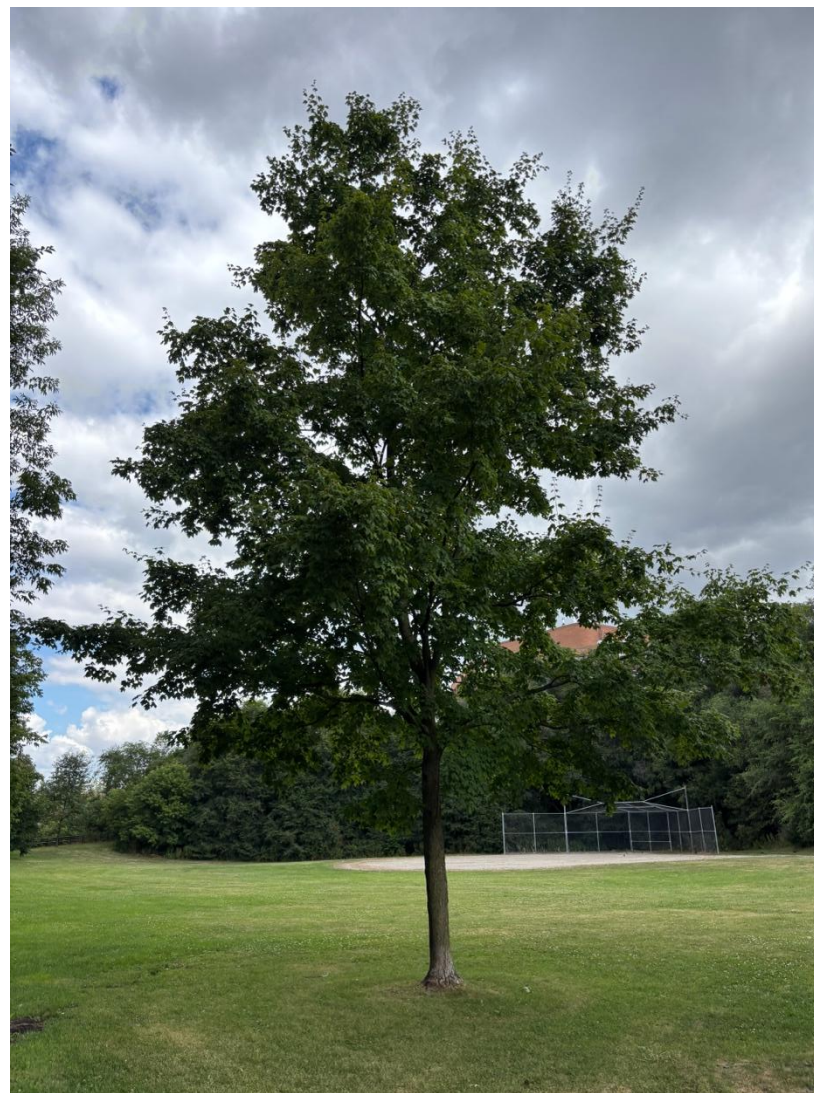
| Nearest Address | Tree # | Scientific Name | Common Name | DBH (cm) | Cat. | MTPZ (m) | TPZ Encroachment | Construction Comments | Crown Pruning Required | Crown Pruning Comments | Status<br>Prune - no injury, Injury (permit), Remove (permit), Removal recommended (condition) | Required Compensation |
|---|---|---|---|---|---|---|---|---|---|---|---|---|
| Woodborough Park | 4273 | <i>Acer saccharum</i> | Sugar Maple | 27 | 4 | 3.6 | No | Accommodation for use of heavy equipment on-site | Approx. 10% of Crown | Prune 1x8cm and 1x 4cm branches for equipment access | Prune - No Injury | |

**Photo 6. Tree 4273, view looking north**
